Asset Condition Assessment & Asset Management Plan

This report summarizes (a) the results of an asset condition assessment study carried out with the objective of establishing the health and condition of fixed assets employed on Erie Thames Power Lines' (ETPL)'s distribution system and (b) provides an asset management plan, covering capital and preventative maintenance investments in distribution system fixed assets for the next 10 years.

Beachville – MS1

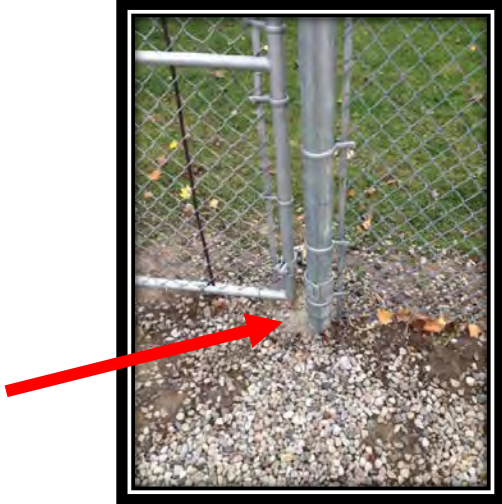
- Gravel low under fence-not done at west side of fence during install

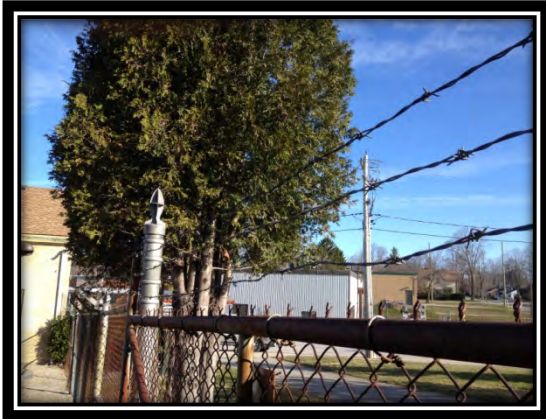
- Pole repairs completed by 3rd party which was found damaged at last inspection

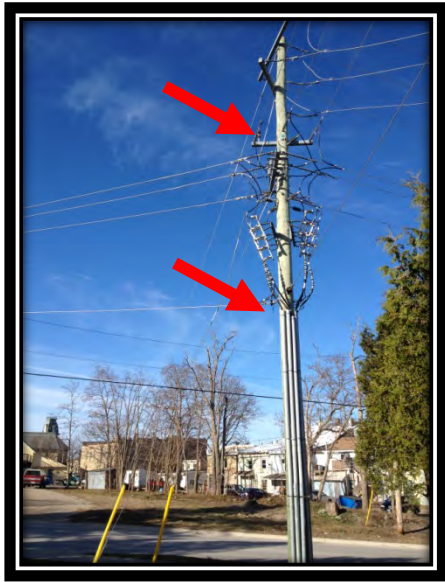
- Phase tape is peeling off and loose on cables on poles

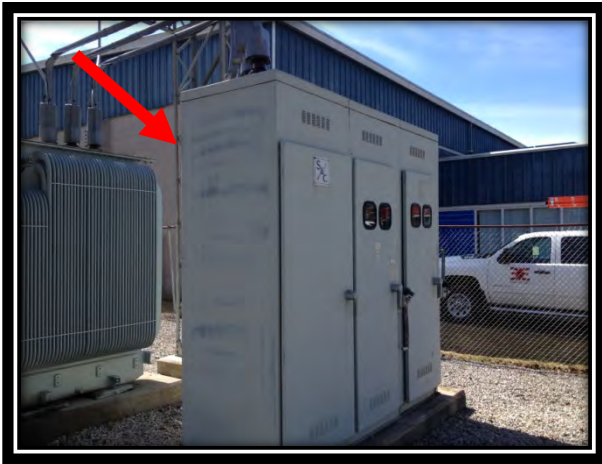
- Minor oil leaks on transformer noted at April 2015 inspections & during November 2015 inspections, continue to monitor

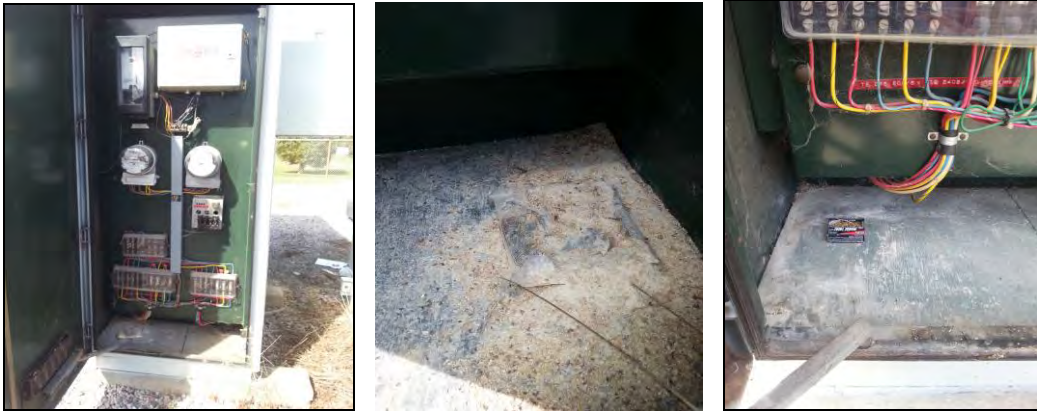
- Rodent droppings indicate a lot of mice in the switch
 - placed rodent poison inside switches for mice/rodents control

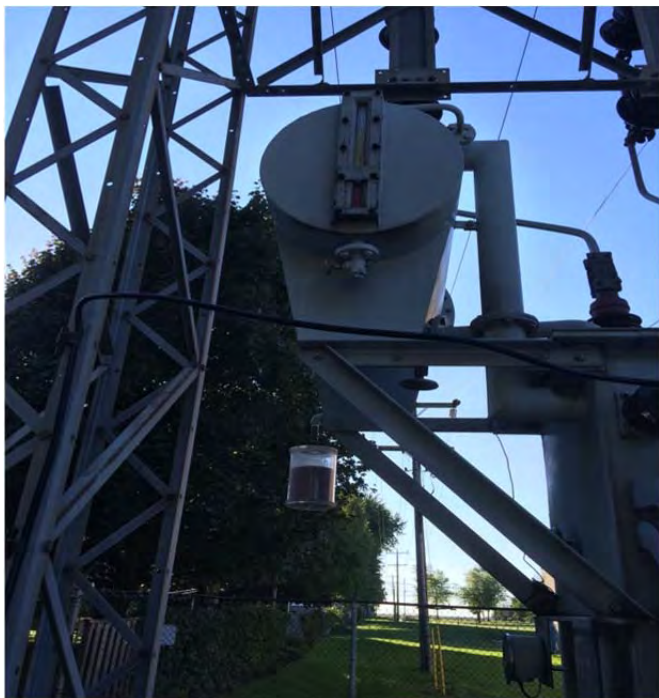
-Transformer continues to have small leak, appears to be from the top lid possibly gasket.

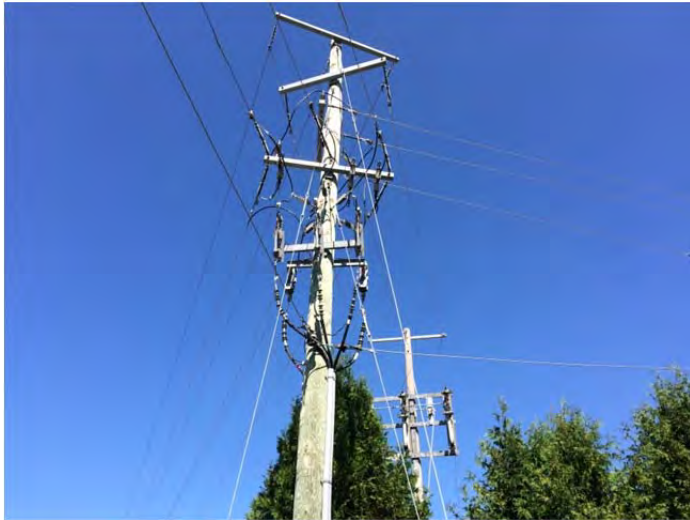
-Pole guying, fibre rods on some guys questionable on spacing

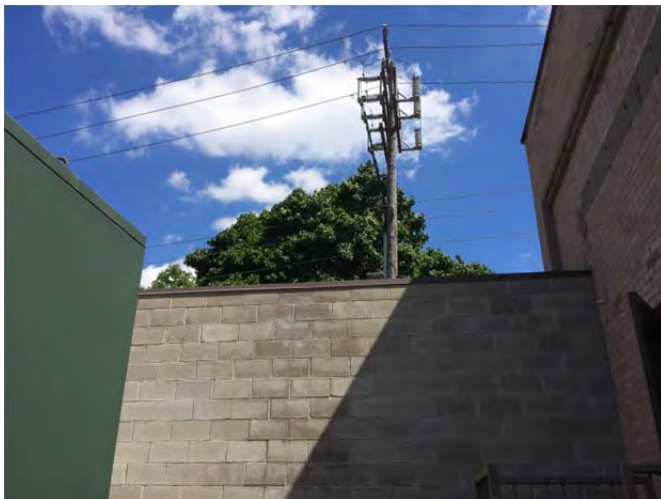
-Pole load break switch should consider replacing porcelain lightning arresters to polymer style due to the risk if a porcelain takes a direct lightning hit and fails violently.

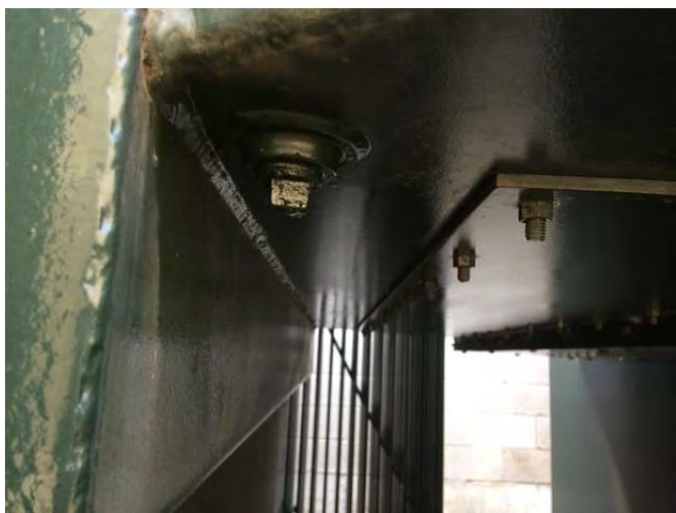
-Transformer showing signs of small leak on primary bushings, oily on bottom of primary throat of transformer

-monitor for now, future investigation may be warranted!
