Asset Condition Assessment & Asset Management Plan

This report summarizes (a) the results of an asset condition assessment study carried out with the objective of establishing the health and condition of fixed assets employed on Erie Thames Power Lines' (ETPL)'s distribution system and (b) provides an asset management plan, covering capital and preventative maintenance investments in distribution system fixed assets for the next 10 years.

Beachville – MS1

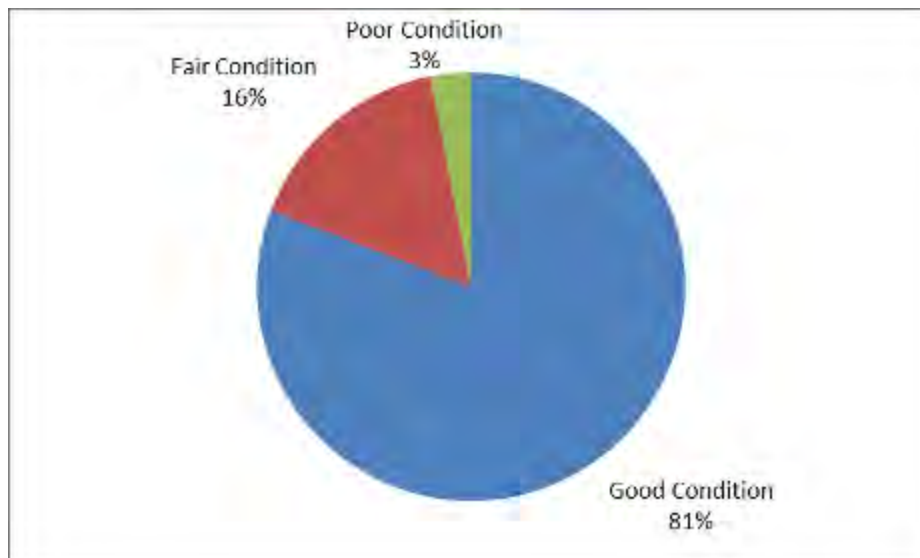
Exhibit 4-4: Pole Conditions (Based on Test Results)

A sample of approximately 1000 wood poles in Embro, Thamesford and Tavistock districts (all in South Region) have been tested recently and we have reviewed the test report. Approximately 3% of the poles were found to be in poor condition and in need of immediate replacement. It is noteworthy that the pole conditions deviate significantly from one district to another. For example, approximately 7% of the poles tested in Tavistock were found to be in poor condition, but only 1% of the poles tested in Embro district were determined to be in poor condition.

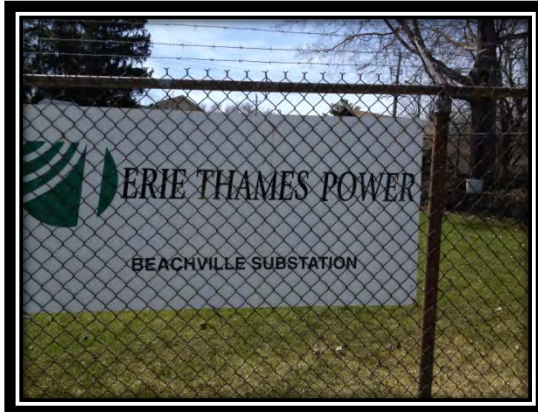
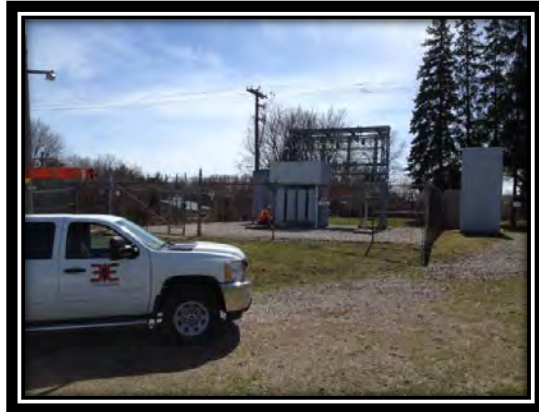
- Trip Hazard in the driveway near the road outside the property fence gate is a potential hazard – needs to be filled in

- Repair sinkhole by the front gate
- Replace broken pole light
- Repair the split termination
- The Transformer is starting to rust – inspection is needed as there may be moisture inside

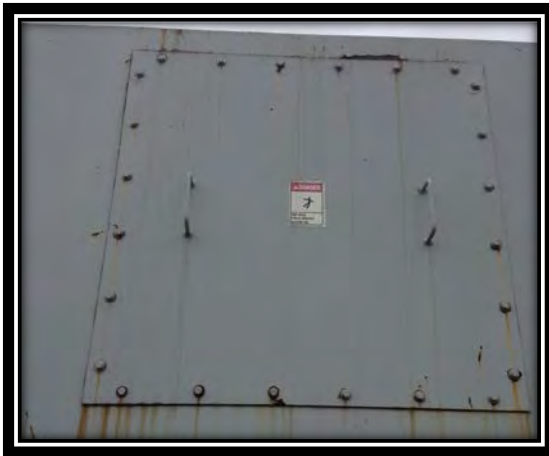
- Transformer starting to rust

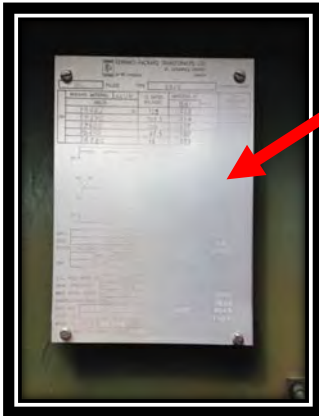
- Name Plate is faded

- Stairs should be painted to slow down rusting further
- Replace nameplate on transformer so it is legible
- Continue with regular bi-annual substation inspections

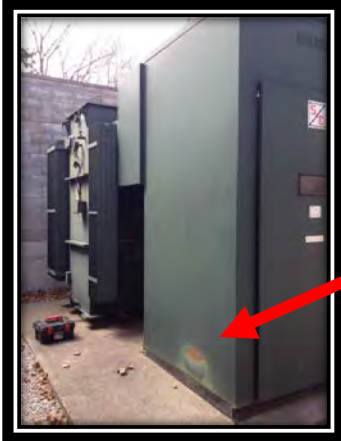
- HV switch on TX paint faded, minor rust spots

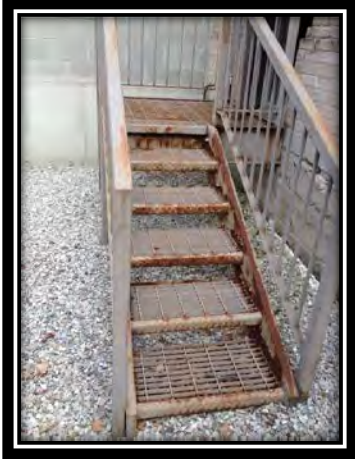
- Stairs are rusting

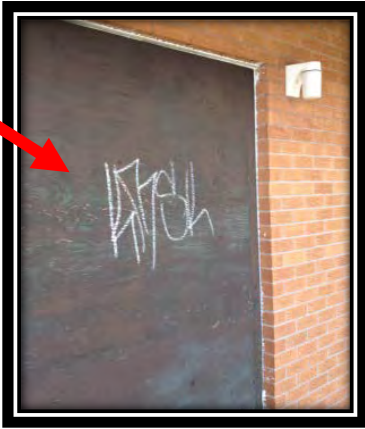
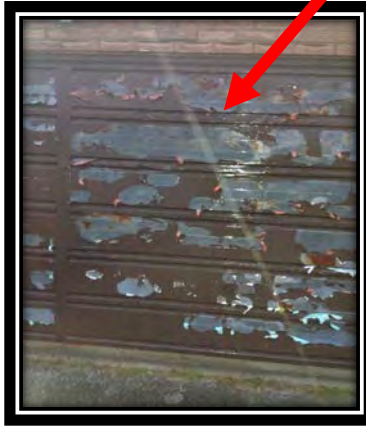
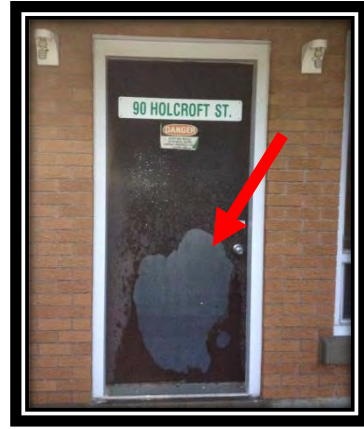
- Paint is fading/peeling off exterior doors, vandalism present and exterior lights on main building door is missing globes

- Recommend paint all exterior doors on the buildings
- Install new outdoor lights
- Repair cracked building cement
- Some lights in the building need repair – possibly bulbs or ballasts
- Continue with regular bi-annual substation inspection

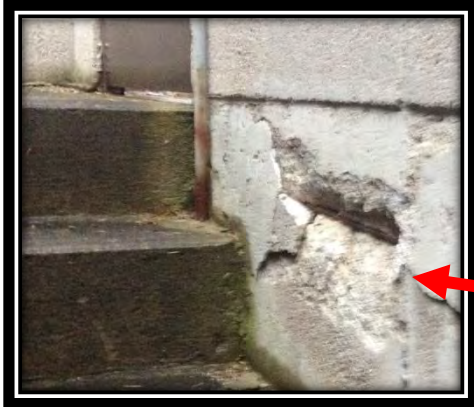
- Building structure concern with cement cracked

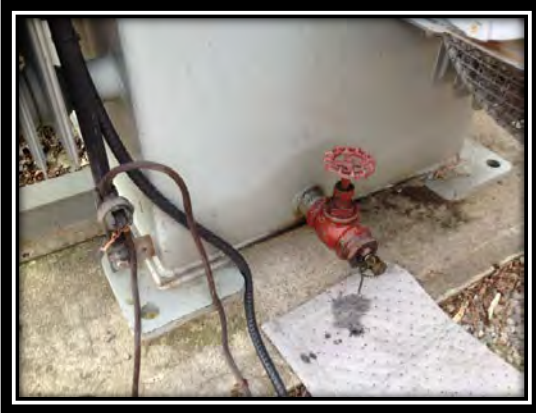
- Minor oil leak at drain valve on TX

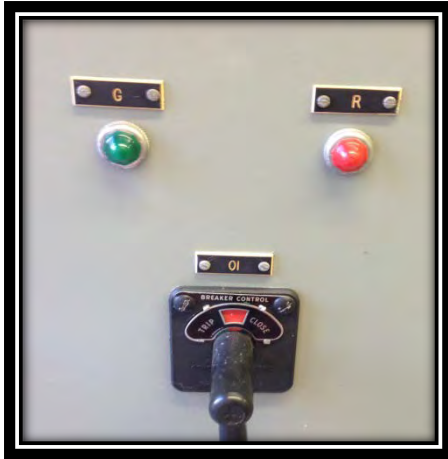
- Bulbs needed for indicating lights on gear

- Monitor drain valve leak on transformer
- Monitor possible moisture getting into building
- Gear indicating lights need new bulbs
- Leaves falling and will need to be cleaned out in the spring, if not cleared will cause problems with gravel and addition weed growth
- Continue with regular bi-annual substation inspection

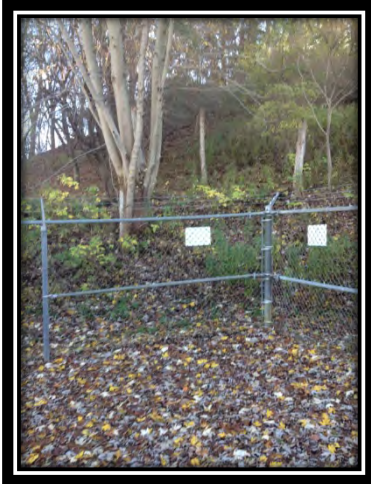
- Station will need cleaning out in spring with leaves present and more leaves to come down off trees.

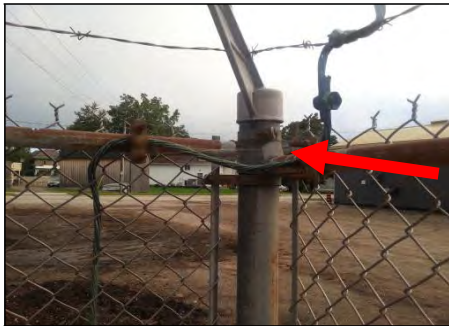
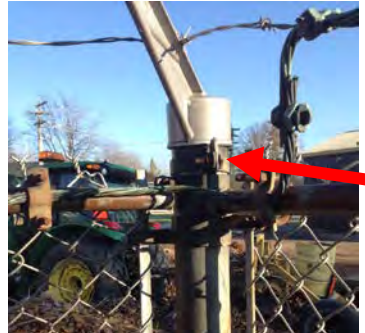
- Top rail requires repair in North East corner

- Repair top rail of fence and the mid rail on fence which is bent – bollards may need to be considered to protect fence from vehicle traffic
- Replace wood poles and cross arms
- Replace 4 yellow guy guards
- Touch-up paint needed on rust area's on switch gear and transformer fins
- Replace fading phase markers on 5kV poles
- Remove yard waste from fence area

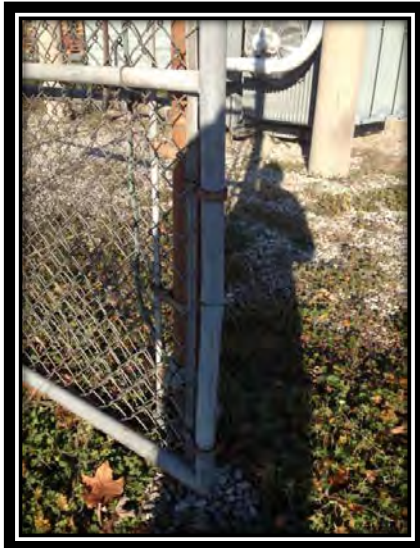
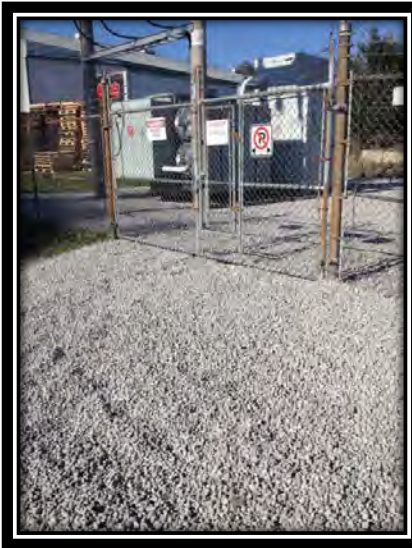
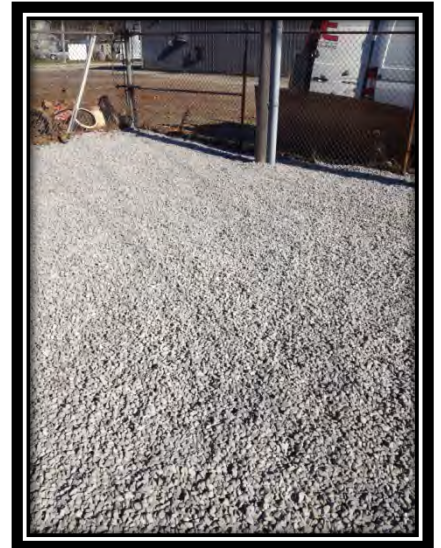
- Gravel added to substation during inspection

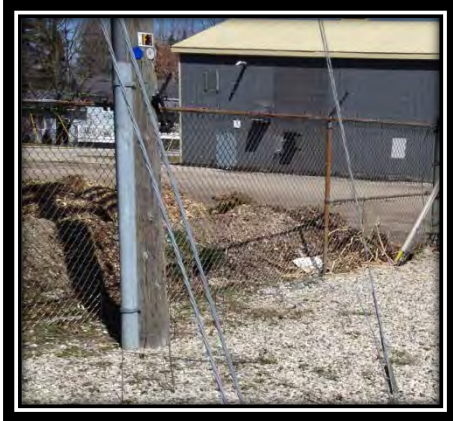
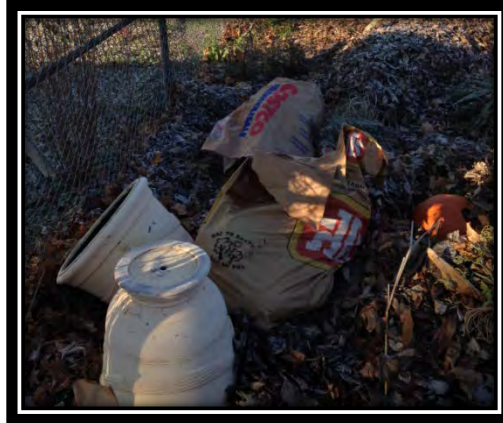
- Yard waste is being piled too close to the fence on north side of station and could potentially allow access over fence

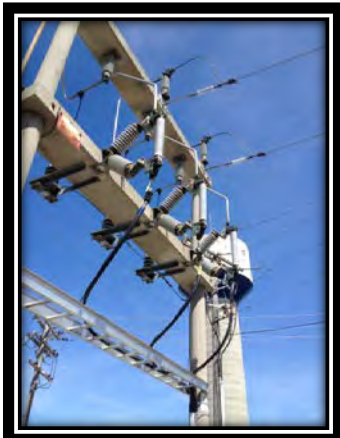
- Danger High Voltage signs required on cable tray

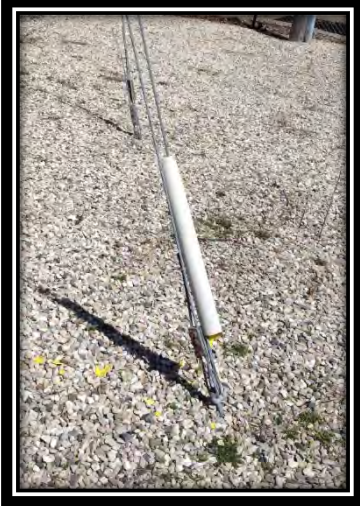
- Guy Guards in poor condition and require replacement (4 Yellow Guards required)

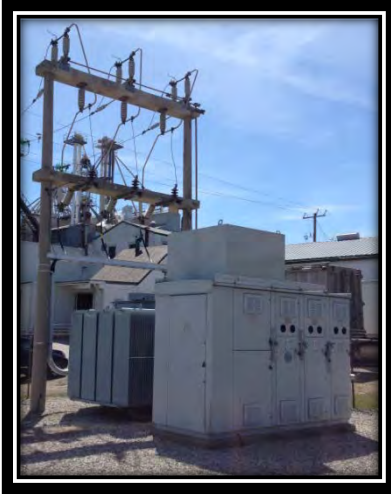
- Rust appearing on switch gear

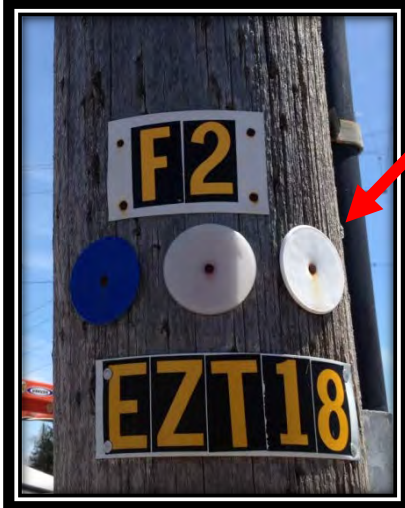
- Phase markers faded on 5kV poles – need to be replaced

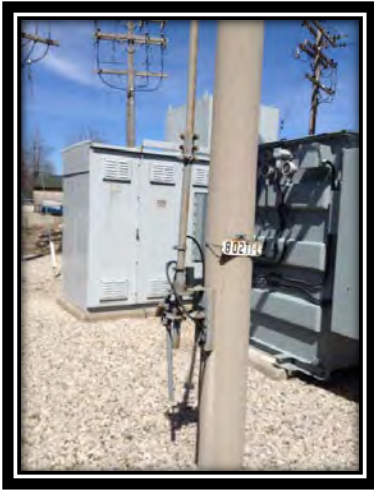
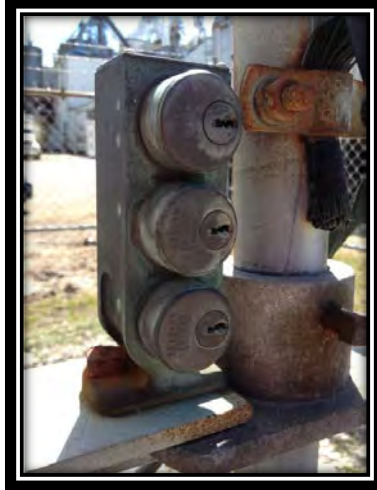
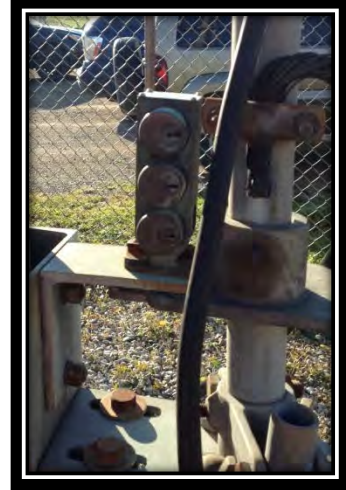
- Air break tower switch interlocks not in sequence – tower will not open without removing interlock

- Interlock not properly sequenced
- Weed spray program needed in 2016, recommend to spray twice per year (spring/fall)
- Continue with regular bi-annual substation inspection

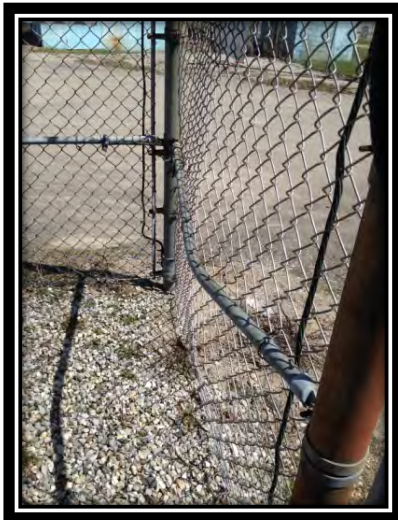
- Minor rust on TX fins
- Fence is bent in and should be repaired

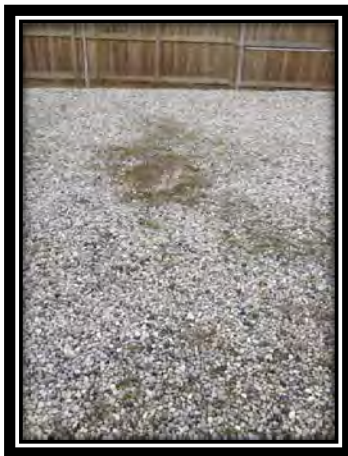
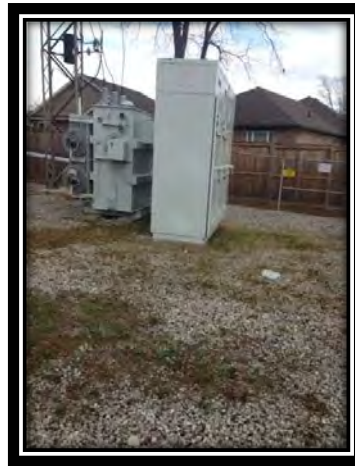
- Vegetation is still present
April 2015

- Re-install metal straps for protective sleeves on High Voltage cables
- Bring in gravel to replenish outside of fence
- Use primary metering data for over-all station loading
- Implement a weed spray program
- Continue with regular bi-annual substation inspection

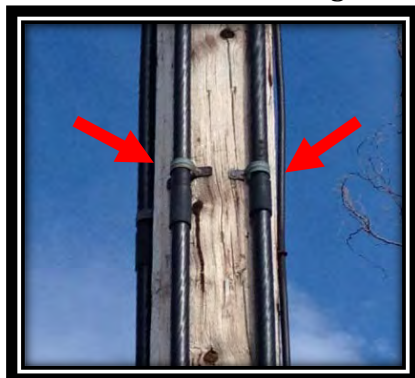
- Protective sleeves on High Voltage cables are not under metal straps

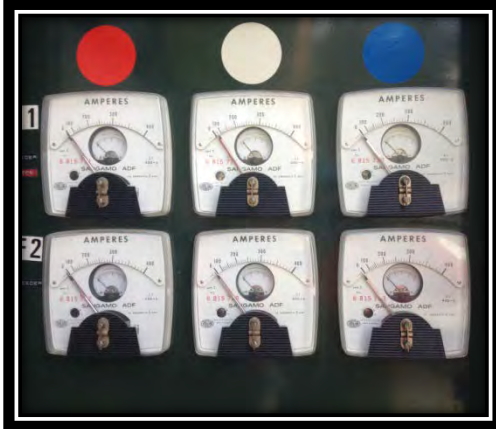
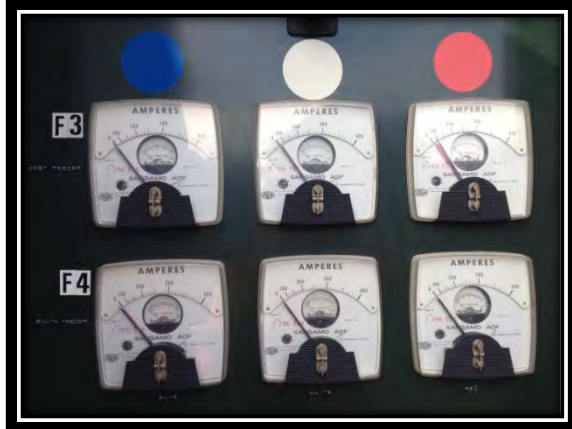
- Light load – is the metering accurate?

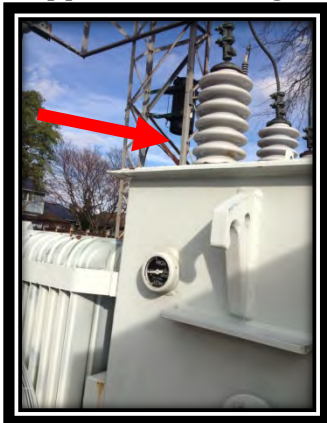
- Chipped bottom ring on south transformer

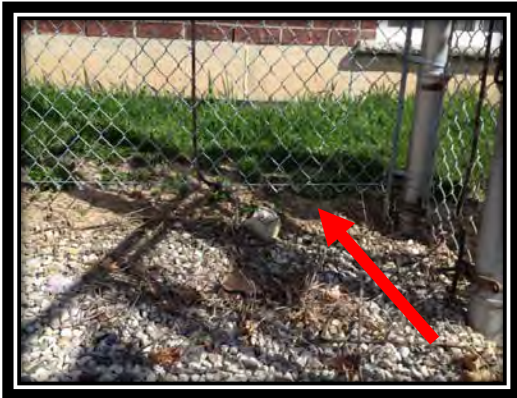
- Gravel low under fence-not done at west side of fence during install

- New transformer installed summer 2015
- Weed spray program is recommended twice a year to control weeds and vegetation growth in substation
- For safety concerns, the neighbors steel satellite dish should be moved away from proximity to station fence
- Gravel level to be reviewed at next inspection following construction and settling, may need additional gravel in Spring 2016
- Grounding of fence to be brought to OESC requirements if required during the spring inspections
- Continue with regular bi-annual substation inspection

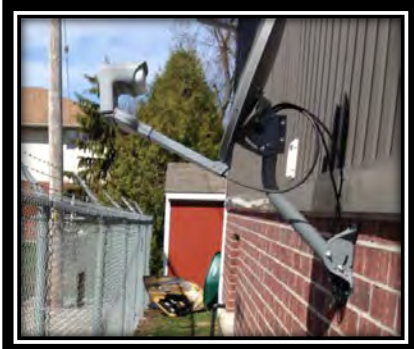
- Satellite dish on neighbor's house requires bonding per code regulations. Satellite dish should be relocated so metal dish and station fence cannot be touched at same time by a person.

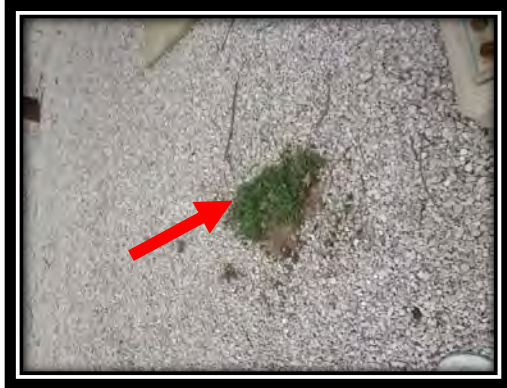
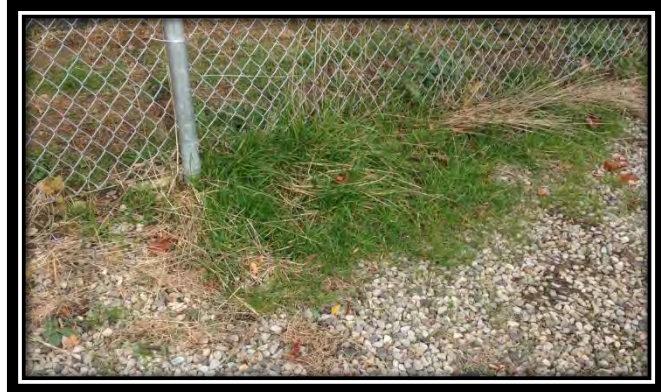
- Vegetation growth present in April 2015 inspection and heavy growth in November 2015

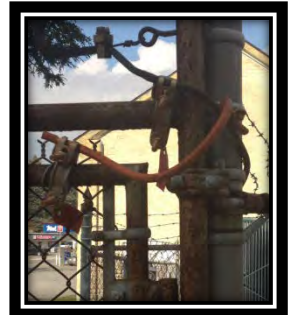
- Additional grounding added to meet OESC

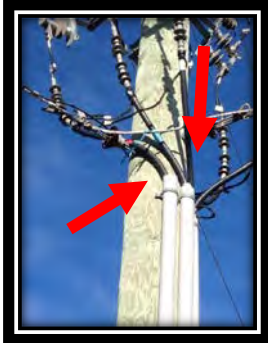
- Wire way labelled

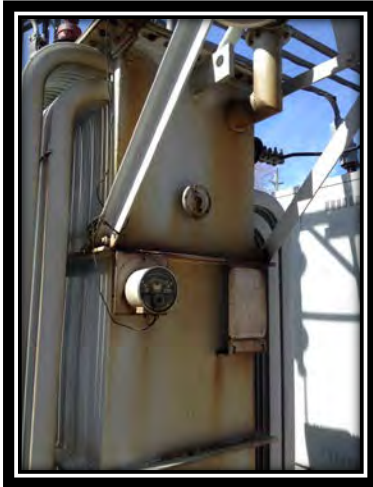
- Transformer is bonded in one place (2-2/0), it is to code to have transformer bonded in two separate locations

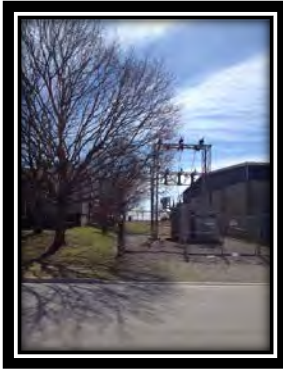
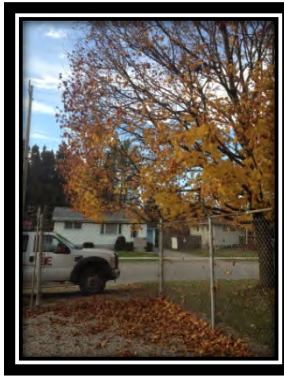
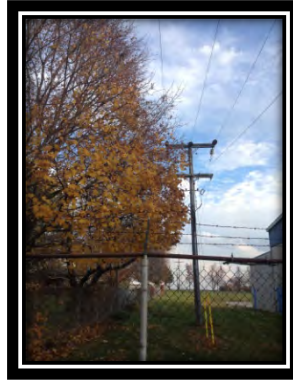
- Neighbors trees are getting in proximity of incoming lines, trimming required

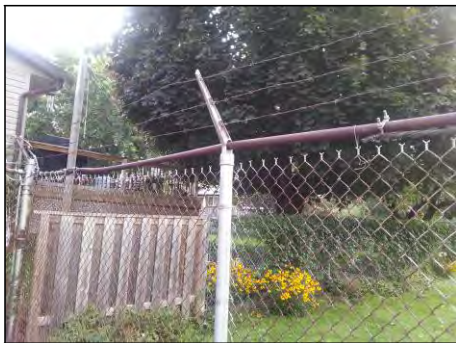
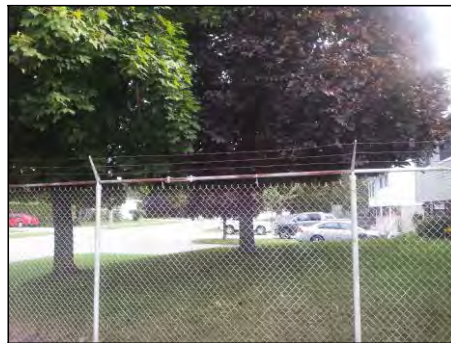
- Barb wire needs replacement soon – loose and very rusty

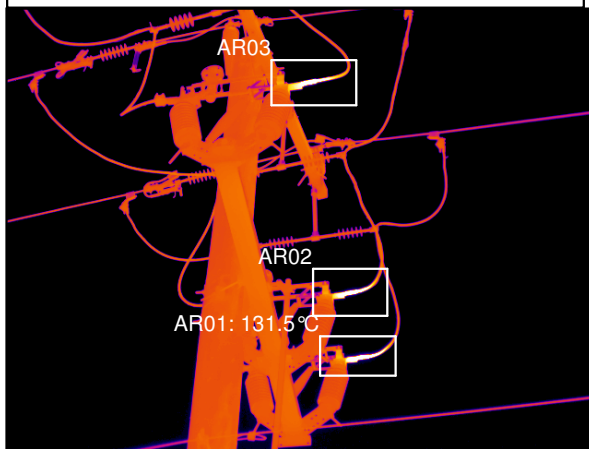
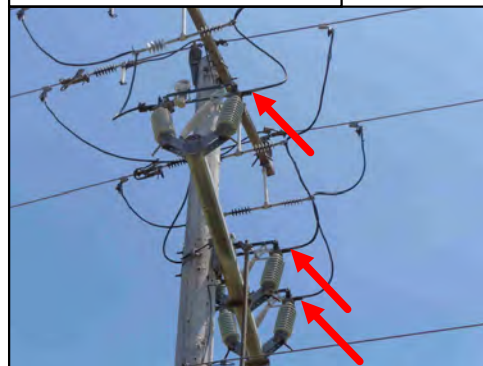
Description: Air brakes

Temperature rise: 109.54 °C
(over ambient)

IR information	Value
Date of creation	2014-06-19
Object parameter	Value
Ambient temperature	22.0°C
Label	Value
AR01 : max	131.5°C
AR02 : max	127.0°C
AR03 : max	99.4°C

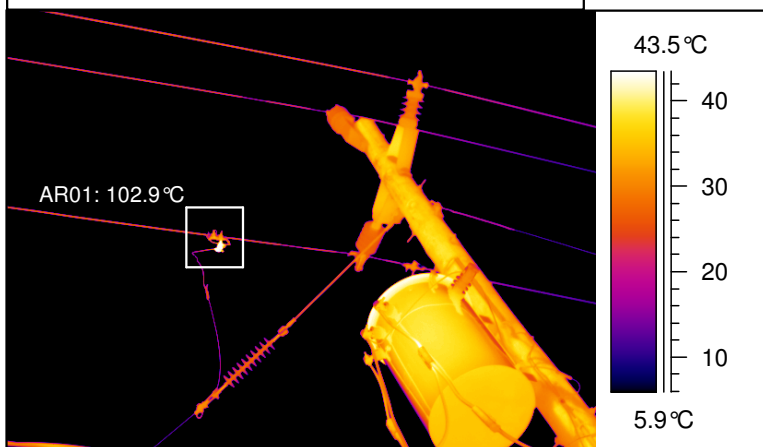
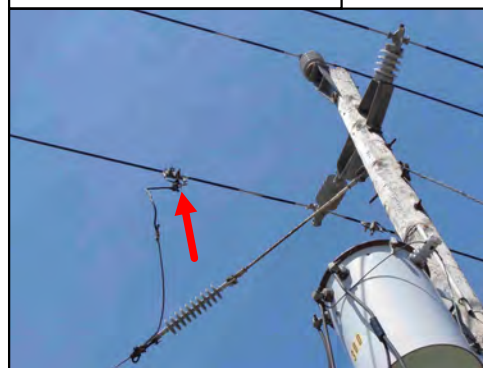
Description: Primary connection

IR information	Value
Date of creation	2014-06-19
Object parameter	Value
Ambient temperature	22.0°C
Label	Value
AR01 : max	102.9°C

Temperature rise: 80.95 °C
(over ambient)

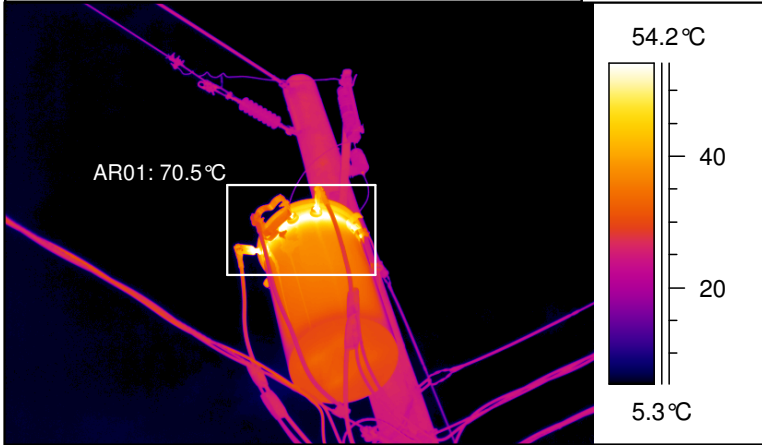
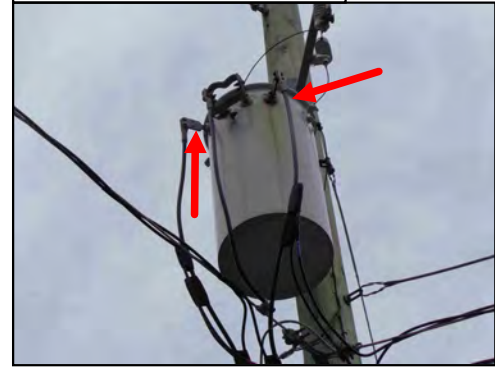
Description: Transformer

Temperature rise: 51.51 °C
(over ambient)

IR information	Value
Date of creation	2014-06-18
Object parameter	Value
Ambient temperature	19.0°C
Label	Value
AR01 : max	70.5°C

Infrared image of the transformer O309 on pole # ET6480.
 Located at intersection of North Street East and York Street in Otterville.
 Heating noted at all of the secondary connections and at the top of the transformer can (at arrow in photo).
 See IR information chart above for maximum temperature inside area box (AR01).

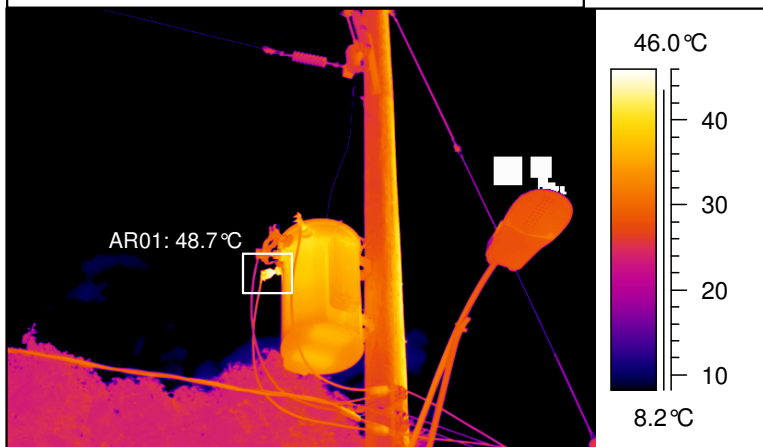
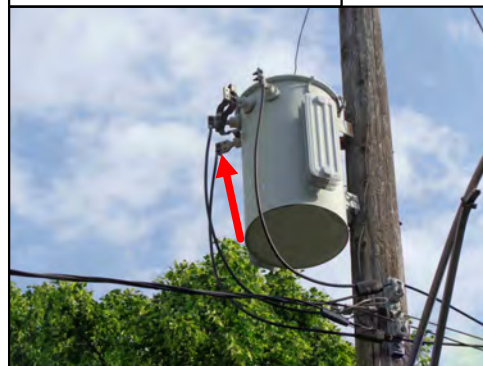
Description: Transformer

Temperature rise: 23.70 °C
(over ambient)

IR information	Value
Date of creation	2014-06-17
Object parameter	Value
Ambient temperature	25.0°C
Label	Value
AR01 : max	48.7°C

Heating noted at the indicated secondary connection (at arrow in photo).

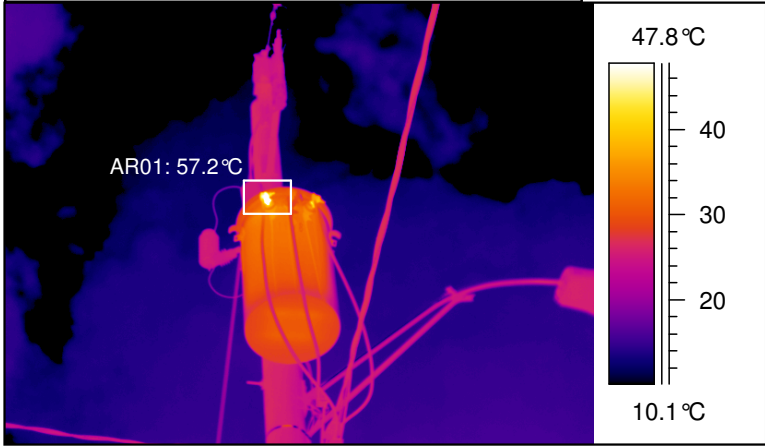
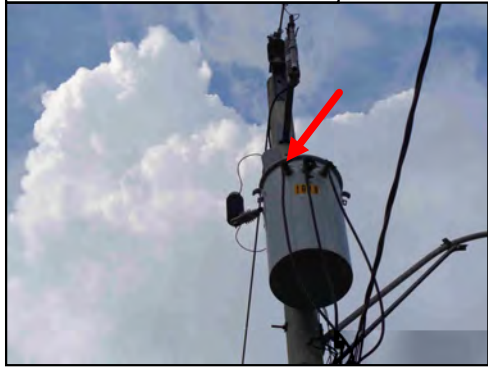
Description: Transformer

Temperature rise: 32.23 °C
(over ambient)

IR information	Value
Date of creation	2014-06-17
Object parameter	Value
Ambient temperature	25.0°C
Label	Value
AR01 : max	57.2°C

Infrared image of the transformer 1018 on pole # ET3866.
 Located on Kensington Avenue in Ingersoll.
 Heating noted at the indicated secondary connection (at arrow in photo).
 See IR information chart above for maximum temperature inside area box (AR01).

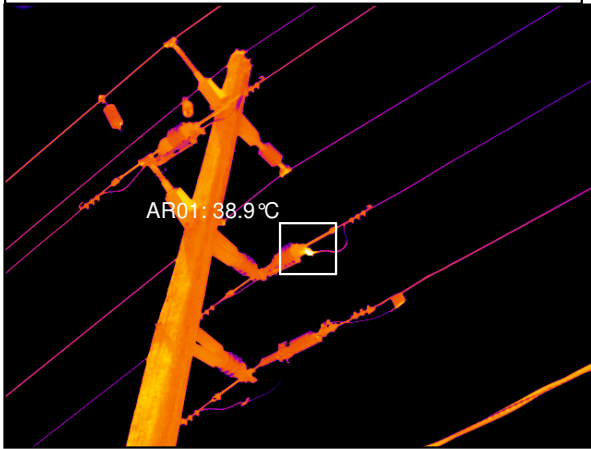
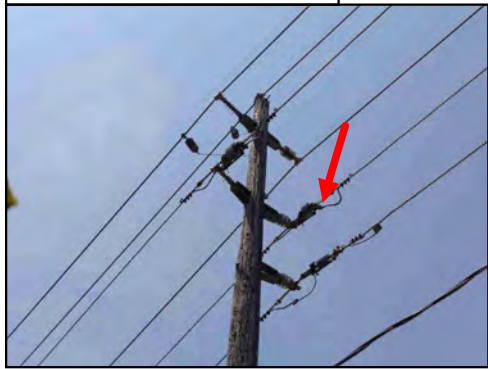
Description: In-line switches

Temperature rise: 10.93 °C
(over ambient)

IR information	Value
Date of creation	2014-06-17
Object parameter	Value
Ambient temperature	28.0°C
Label	Value
AR01 : max	38.9°C

Infrared image of the in-line switches on pole # ET3732.
 Located at 155 Anne Street in Ingersoll.
 Heating noted at the indicated connection on the top road-side switch (at arrow in photo).
 See IR information chart above for maximum temperature inside area box (AR01).

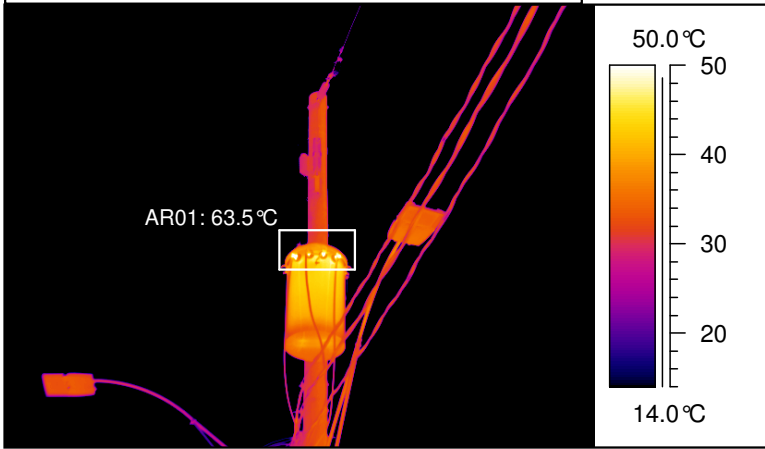
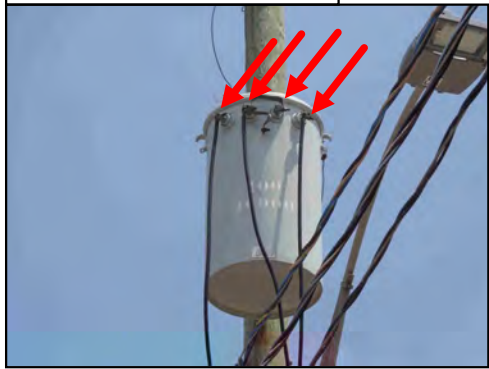
Description: Transformer

Temperature rise: 35.47 °C
(over ambient)

IR information	Value
Date of creation	2014-06-17
Object parameter	Value
Ambient temperature	28.0°C
Label	Value
AR01 : max	63.5°C

Infrared image of the transformer 0626 on pole # ET4352.
 Located on Oxford Street parking, behind King in Ingersoll.
 Heating noted at all of the secondary connections (at arrows in photo).
 See IR information chart above for maximum temperature inside area box (AR01).

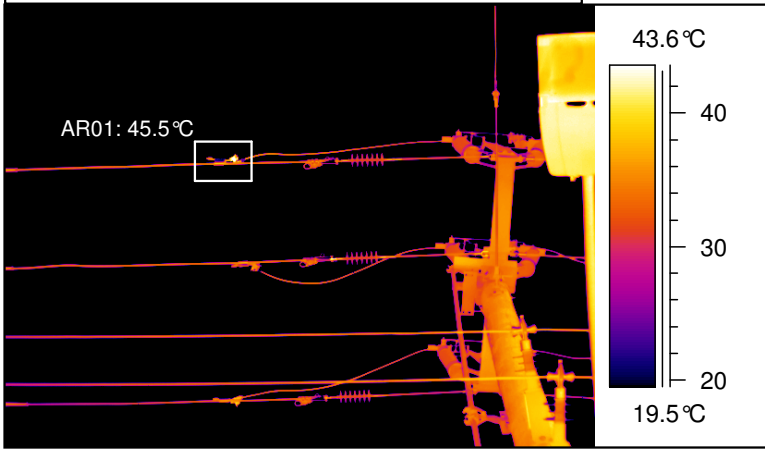
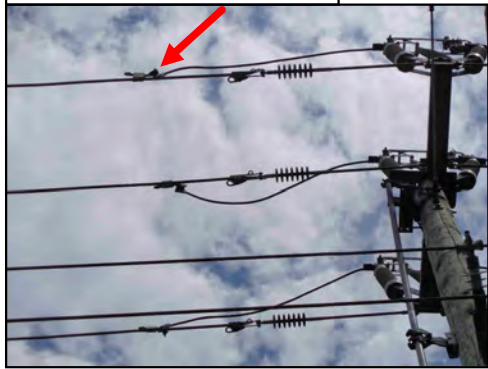
Description: In-line switches

Temperature rise: 17.50 °C
(over ambient)

IR information	Value
Date of creation	2014-06-17
Object parameter	Value
Ambient temperature	28.0°C
Label	Value
AR01 : max	45.5°C

Infrared image of the in-line switches IN08 on pole # ET8135.
 Located on Thames Street South in Ingersoll.
 Heating noted at the indicated connection (at arrow in photo).
 See IR information chart above for maximum temperature inside area box (AR01).

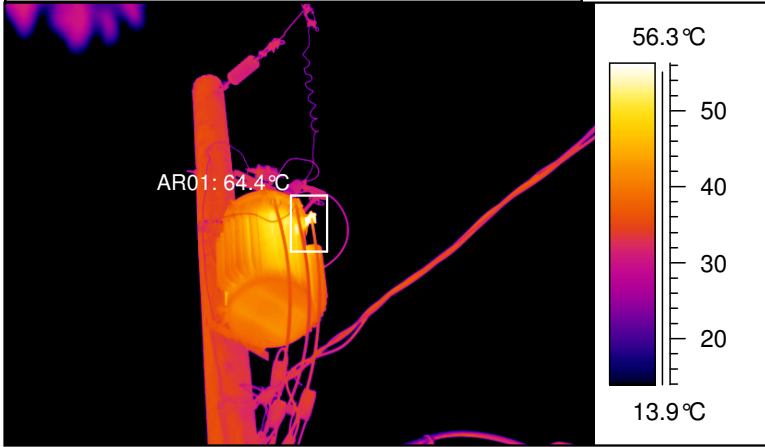
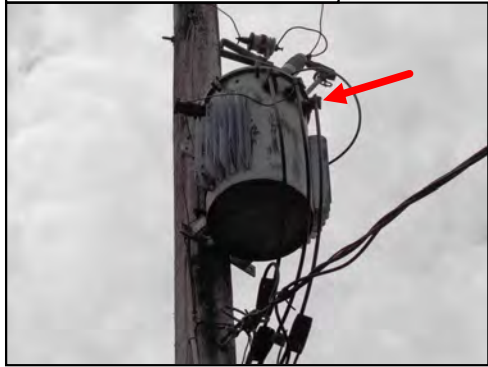
Description: Transformer

Temperature rise: 36.43 °C
(over ambient)

IR information	Value
Date of creation	2014-06-17
Object parameter	Value
Ambient temperature	28.0°C
Label	Value
AR01 : max	64.4°C

Infrared image of the transformer 023 on pole # ET8167.
 Located at intersection of Cottage Street and Thames Street South in Ingersoll.
 Heating noted at the indicated secondary connection (at arrow in photo).
 See IR information chart above for maximum temperature inside area box (AR01).

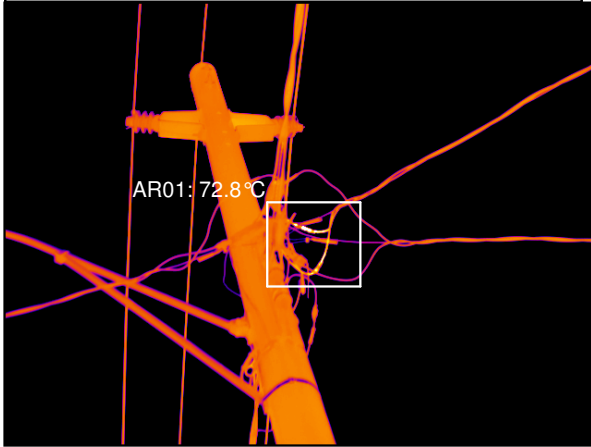
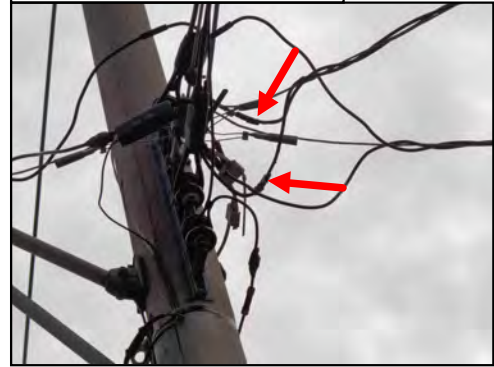
Description: Service connections

Temperature rise: 44.78 °C
(over ambient)

IR information	Value
Date of creation	2014-06-17
Object parameter	Value
Ambient temperature	28.0°C
Label	Value
AR01 : max	72.8°C

Infrared image of service connections on pole # ET4169.
 Located at 148 Caroll Street in Ingersoll.
 Heating noted at the indicated service connections (at arrows in photo).
 See IR information chart above for maximum temperature inside area box (AR01).

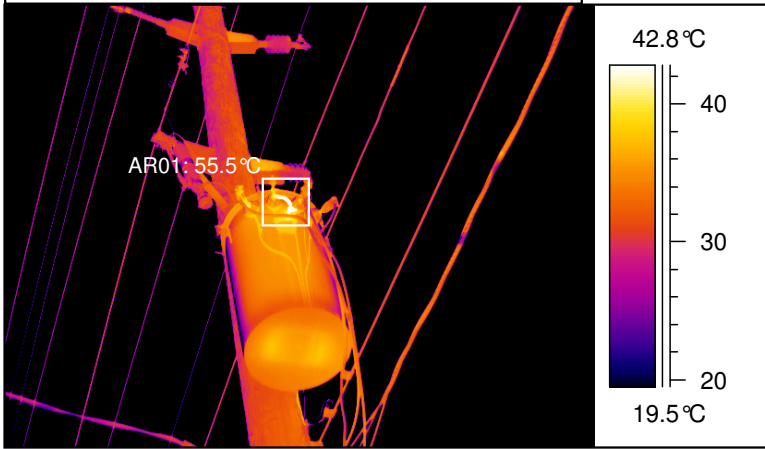
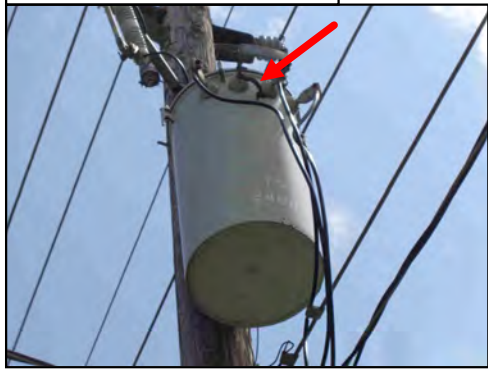
Description: Transformer

Temperature rise: 27.49 °C
(over ambient)

IR information	Value
Date of creation	2014-06-17
Object parameter	Value
Ambient temperature	28.0°C
Label	Value
AR01 : max	55.5°C

Infrared image of the transformer 0161 on pole # ET4138.
 Located at 272 Harris Street in Ingersoll.
 Heating noted at the ground strap connection (at arrow in photo).
 See IR information chart above for maximum temperature inside area box (AR01).

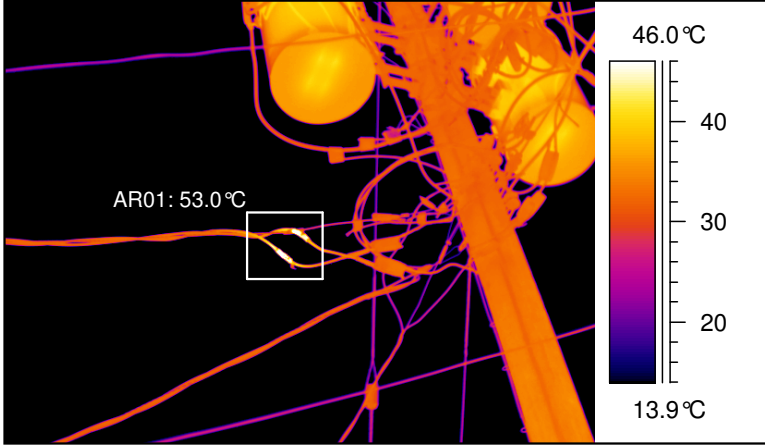
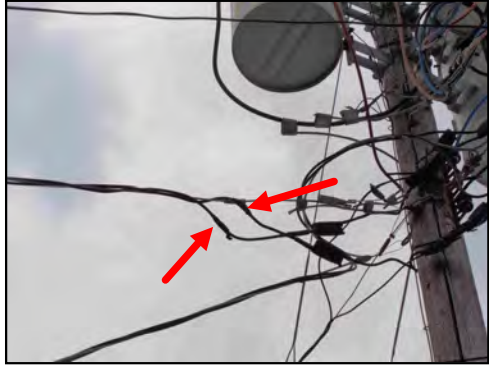
Description: Service connection

Temperature rise: 25.05 °C
(over ambient)

IR information	Value
Date of creation	2014-06-17
Object parameter	Value
Ambient temperature	28.0°C
Label	Value
AR01 : max	53.0°C

Infrared image of service connections on pole # ET4939.
 Located on Thames Street South behind H&R Block in Ingersoll.
 Heating noted at the indicated service connections (at arrows in photo).
 See IR information chart above for maximum temperature inside area box (AR01).

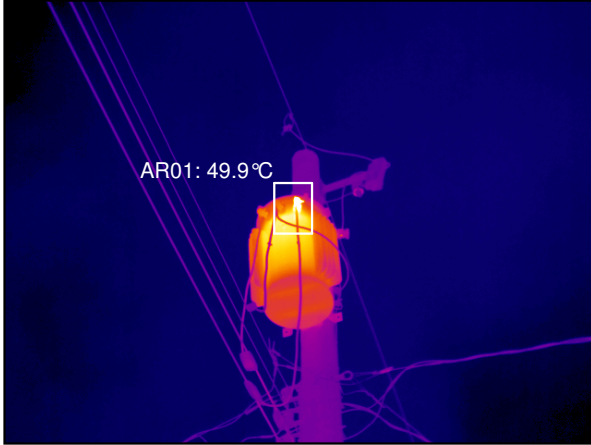
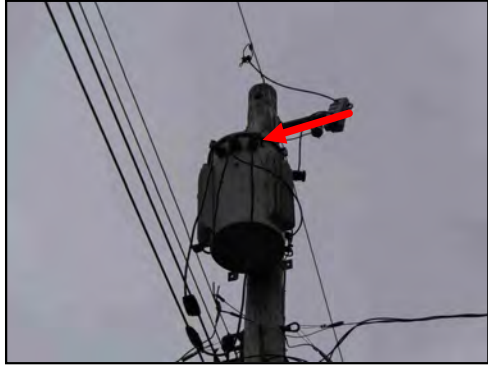
Description: Transformer

Temperature rise: 31.87 °C
(over ambient)

IR information	Value
Date of creation	2014-06-18
Object parameter	Value
Ambient temperature	18.0°C
Label	Value
AR01 : max	49.9°C

Infrared image of the transformer B35 on pole # ET0223.
 Located at 434849 Zorra Line in Beachville.
 Heating noted at the indicated secondary connection (at arrow in photo).
 See IR information chart above for maximum temperature inside area box (AR01).

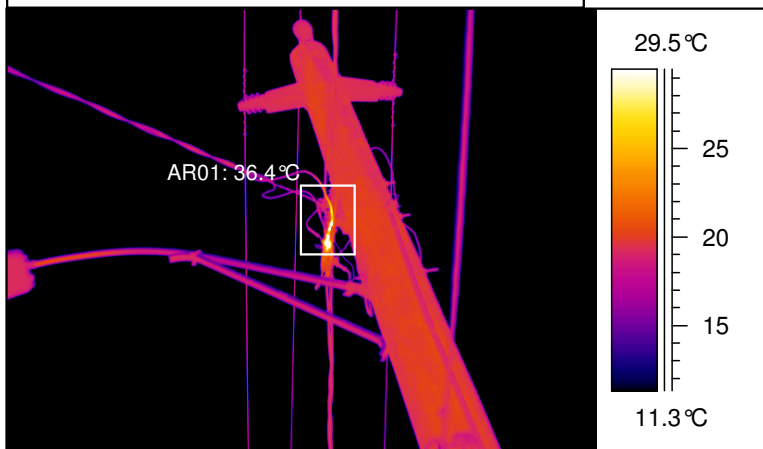
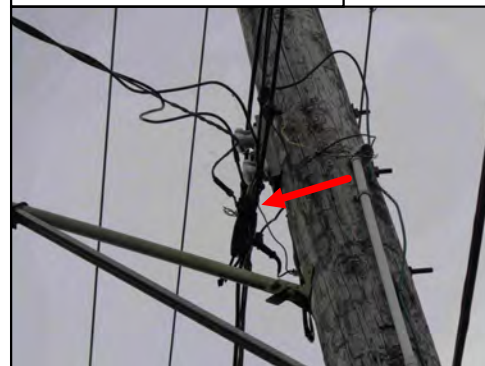
Description: **Service connection**

Temperature rise: 18.42 °C
(over ambient)

IR information	Value
Date of creation	2014-06-18
Object parameter	Value
Ambient temperature	18.0°C
Label	Value
AR01 : max	36.4°C

Heating noted at the indicated service connection (at arrow in photo).

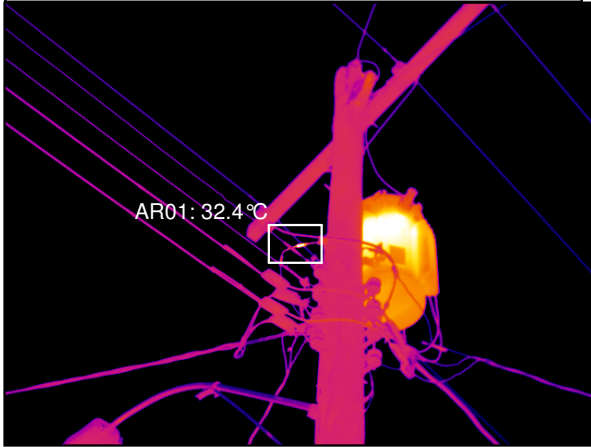
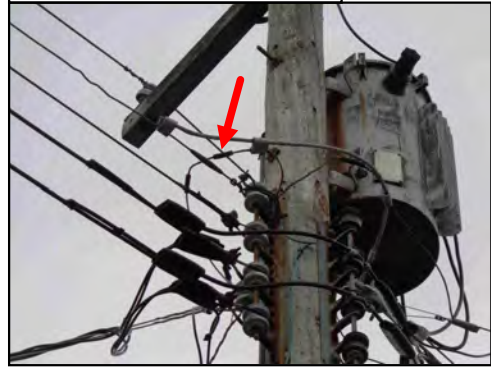
Description: Service connection

Temperature rise: 14.39 °C
(over ambient)

IR information	Value
Date of creation	2014-06-18
Object parameter	Value
Ambient temperature	18.0°C
Label	Value
AR01 : max	32.4°C

Infrared image of a service connection on pole # ET8222.
 Located on Beachville Road East near the Library in Beachville.
 Heating noted at the indicated service (insulink) connection (at arrow in photo).
 See IR information chart above for maximum temperature inside area box (AR01).

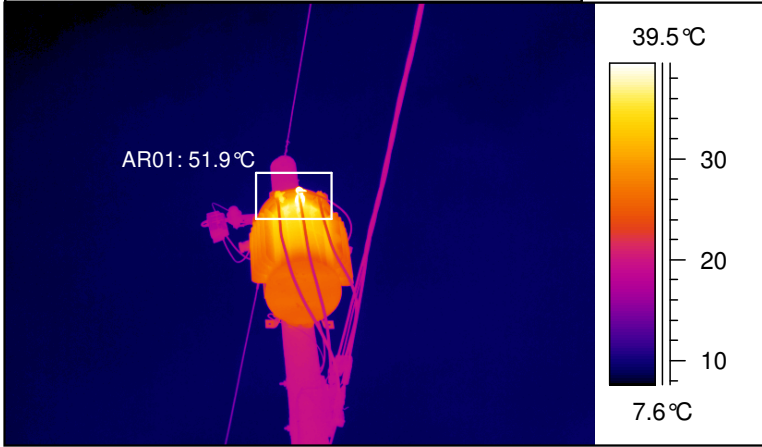
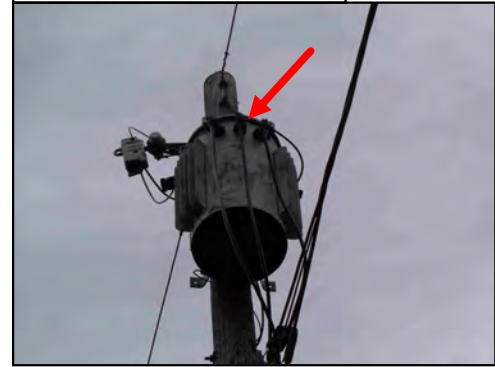
Description: Transformer

Temperature rise: 33.86 °C
(over ambient)

IR information	Value
Date of creation	2014-06-18
Object parameter	Value
Ambient temperature	18.0°C
Label	Value
AR01 : max	51.9°C

Infrared image of the transformer B4 on pole # ET8255.
 Located at 584429 Beachville Road West in Beachville.
 Heating noted at the indicated secondary connection (at arrow in photo).
 See IR information chart above for maximum temperature inside area box (AR01).

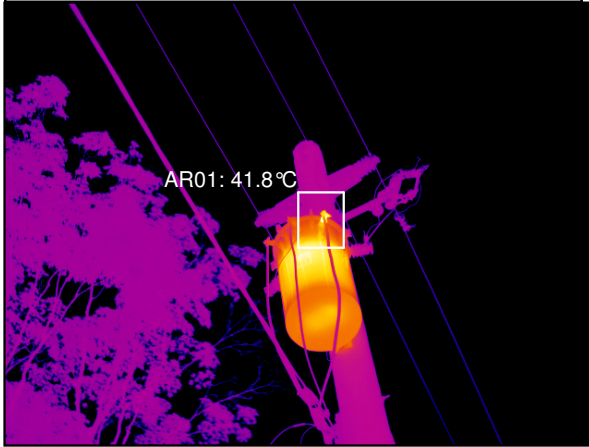
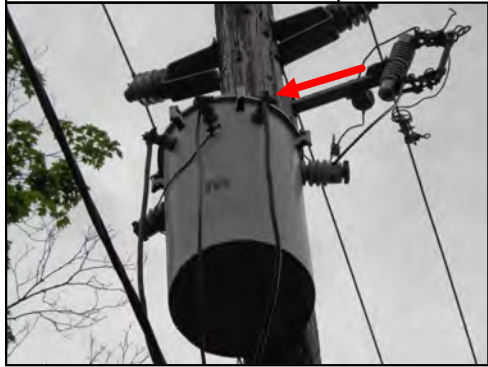
Description: Transformer

Temperature rise: 23.81 °C
(over ambient)

IR information	Value
Date of creation	2014-06-18
Object parameter	Value
Ambient temperature	18.0°C
Label	Value
AR01 : max	41.8°C

Infrared image of the transformer B26 on pole # ET1446.
 Located at 434741 West Mill in Beachville.
 Heating noted at the indicated secondary connection (at arrow in photo).
 See IR information chart above for maximum temperature inside area box (AR01).

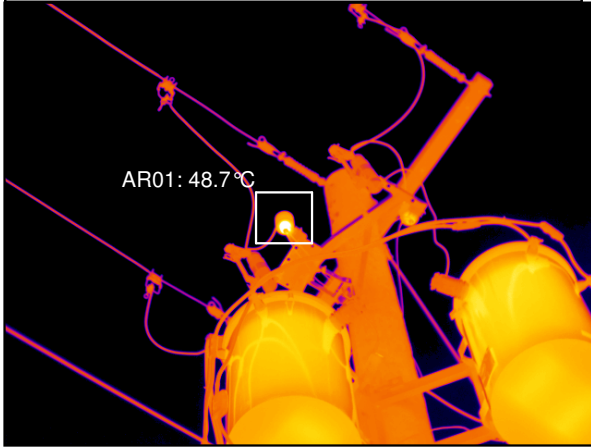
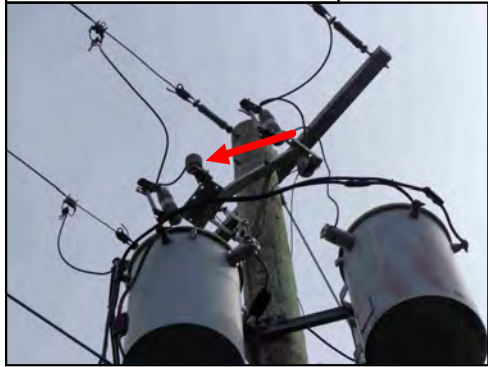
Description: Lightning Arrestor

Temperature rise: 30.74 °C
(over ambient)

IR information	Value
Date of creation	2014-06-18
Object parameter	Value
Ambient temperature	18.0°C
Label	Value
AR01 : max	48.7°C

Infrared image of the transformers O333 on pole # ET6464.
 Located at intersection of Wellington Street and John Street in Otterville.
 Heating noted at the middle arrester (at arrow in photo).
 See IR information chart above for maximum temperature inside area box (AR01).

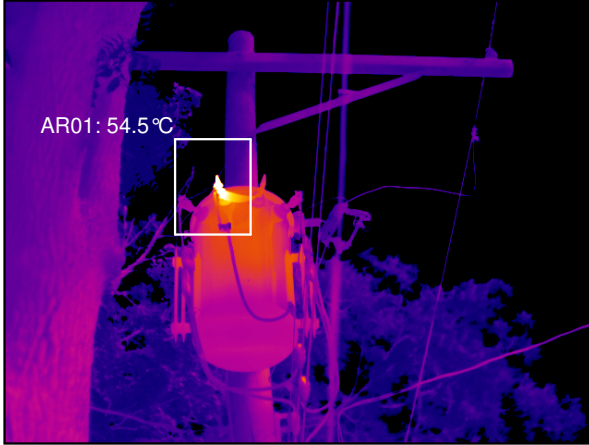
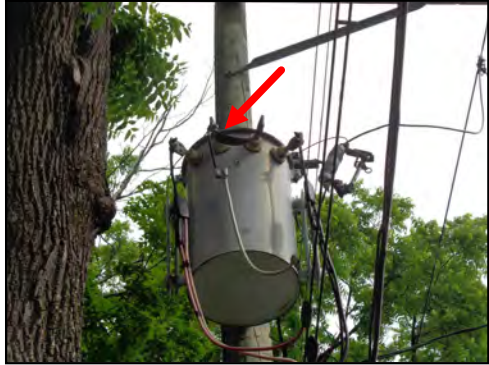
Description: Transformer

Temperature rise: 35.50 °C
(over ambient)

IR information	Value
Date of creation	2014-06-18
Object parameter	Value
Ambient temperature	19.0°C
Label	Value
AR01 : max	54.5°C

Infrared image of the transformer O325 on pole # ET5917.
 Located at 118 John Street South in Otterville.
 Heating noted at the indicated neutral strap connection (at arrow in photo).
 See IR information chart above for maximum temperature inside area box (AR01).

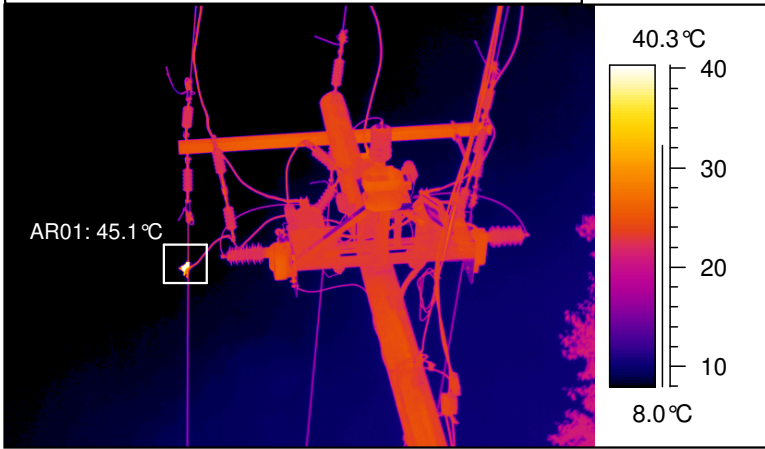
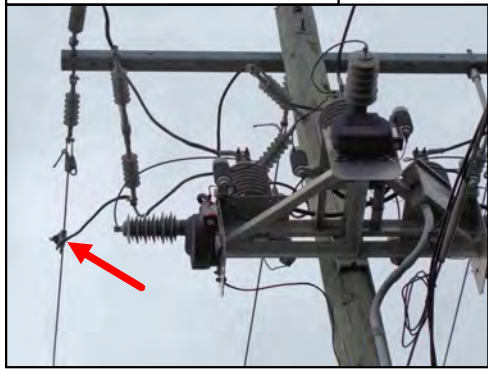
Description: In-line switches

Temperature rise: 26.06 °C
(over ambient)

IR information	Value
Date of creation	2014-06-18
Object parameter	Value
Ambient temperature	19.0°C
Label	Value
AR01 : max	45.1°C

Infrared image of the meter pole # ET6412.
 Located at 303 Main Street East in Otterville.
 Heating noted at the road-side primary connection (at arrow in photo).
 See IR information chart above for maximum temperature inside area box (AR01).
