Asset Condition Assessment & Asset Management Plan

This report summarizes (a) the results of an asset condition assessment study carried out with the objective of establishing the health and condition of fixed assets employed on Erie Thames Power Lines' (ETPL)'s distribution system and (b) provides an asset management plan, covering capital and preventative maintenance investments in distribution system fixed assets for the next 10 years.

Beachville – MS1

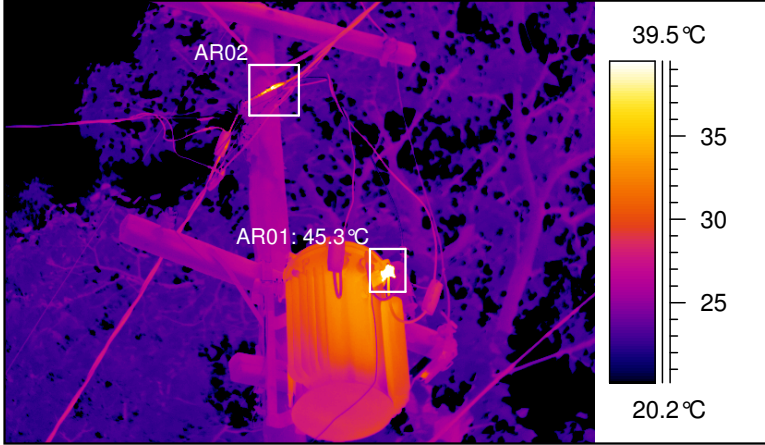
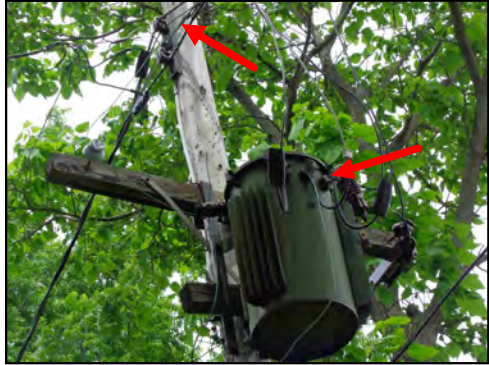
Description: Transformer

Temperature rise: 26.31 °C
(over ambient)

IR information	Value
Date of creation	2014-06-18
Object parameter	Value
Ambient temperature	19.0°C
Label	Value
AR01 : max	45.3°C
AR02 : max	42.6°C

Infrared image of the transformer O349 on pole # ET5938.
 Located at 71 North Street West in Otterville.
 Heating noted at the indicated secondary connection and service connection (at arrows in photo).
 See IR information chart above for maximum temperature inside area box (AR01).

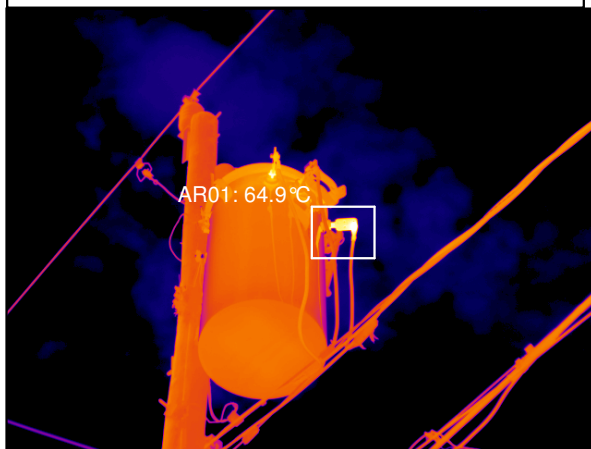
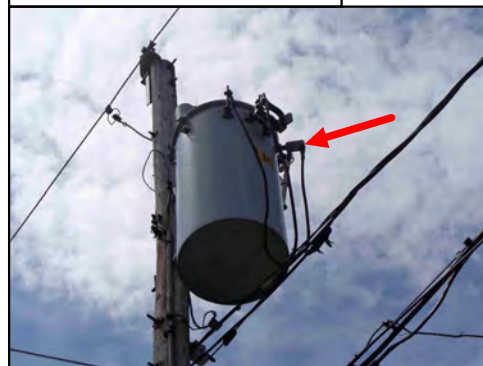
Temperature rise: 41.91 °C
(over ambient)

Heating noted at the indicated road side secondary connection (at arrow in photo).

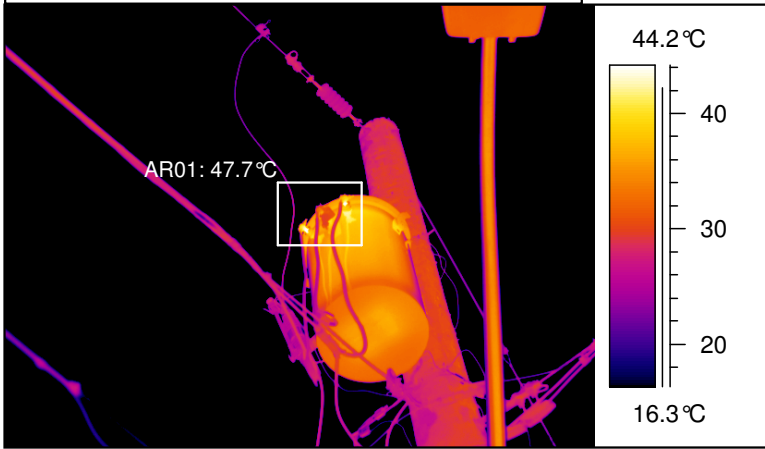
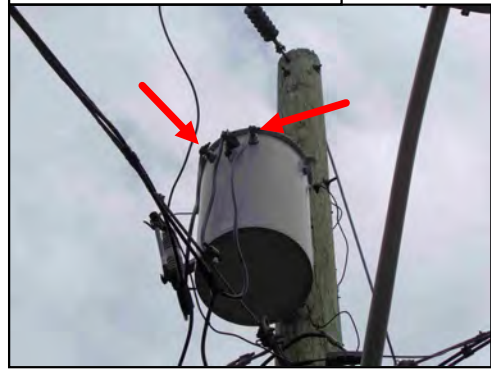
Temperature rise: 24.75 °C
(over ambient)

Infrared image of the transformer N26on pole # ET5355.
 Located at intersection of Brode Street and John Street in Norwich.
 Heating noted at the indicated secondary connections (at arrows in photo).
 See IR information chart above for maximum temperature inside area box (AR01).

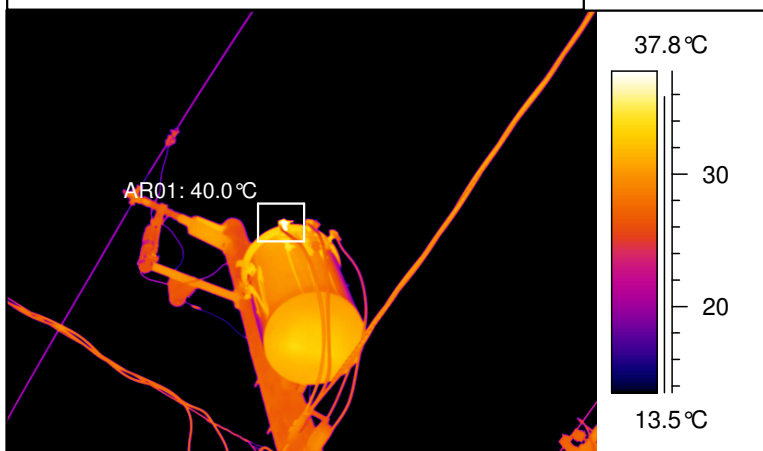
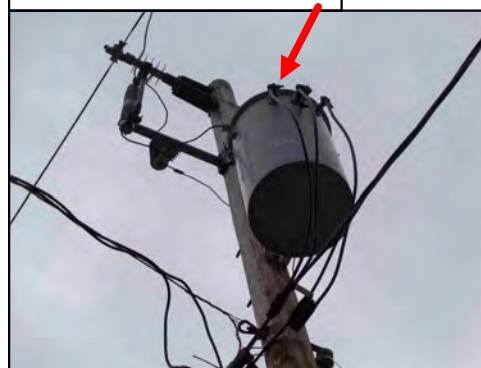
Temperature rise: 16.96 °C
(over ambient)

Heating noted at the indicated secondary connection (at arrow in photo).

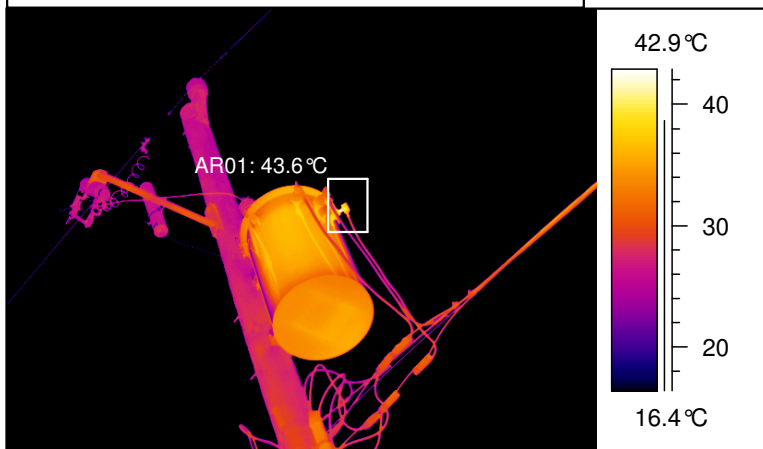
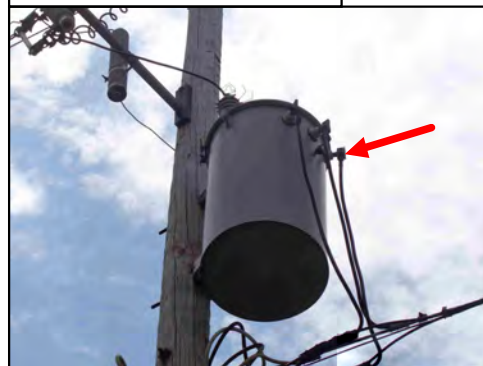
Temperature rise: 20.57 °C
(over ambient)

Heating noted at the indicated field side secondary connection (at arrow in photo).

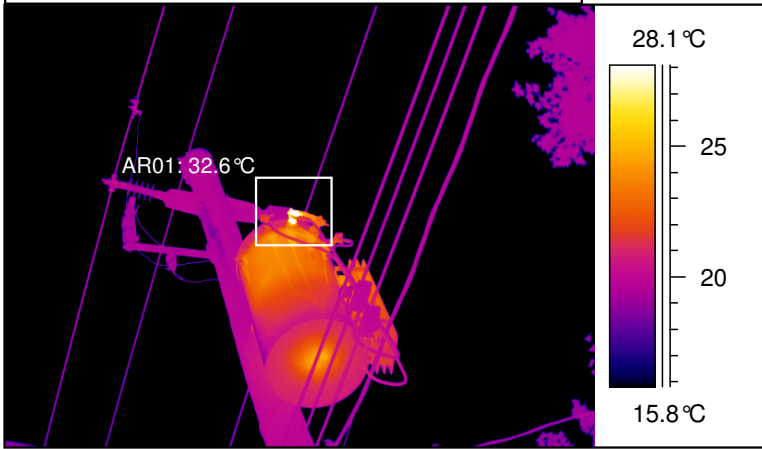
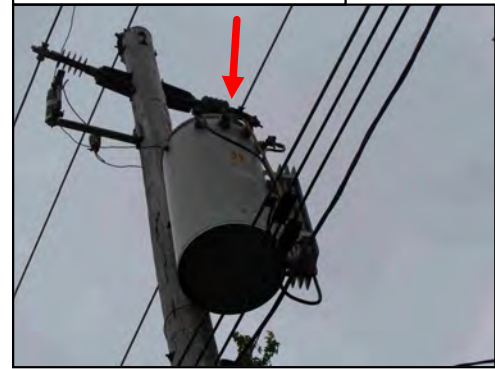
Temperature rise: 14.61 °C
(over ambient)

Infrared image of the transformer A0245 on pole # ET0114.
 Located at 11 Forest Street in Aylmer.
 Heating noted at the indicated neutral connection (at arrow in photo).
 See IR information chart above for maximum temperature inside area box (AR01).

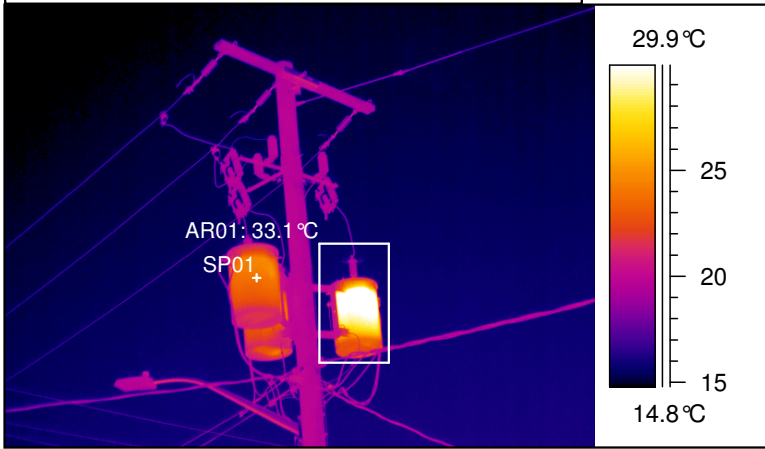
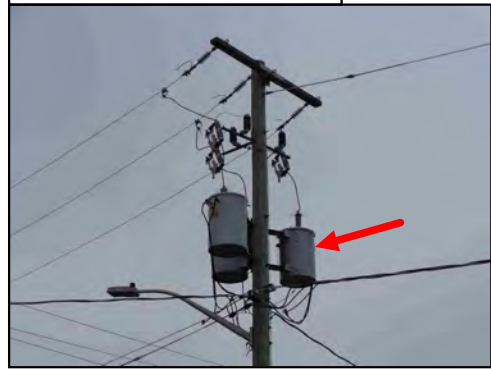
Temperature rise: 15.07 °C
(over ambient)

Infrared image of the transformer A0188 on pole # ET0103.
 Located on Spruce Street in Aylmer.
 Uneven transformer heating was noted.
 See IR information chart above for maximum temperature inside area box (AR01).

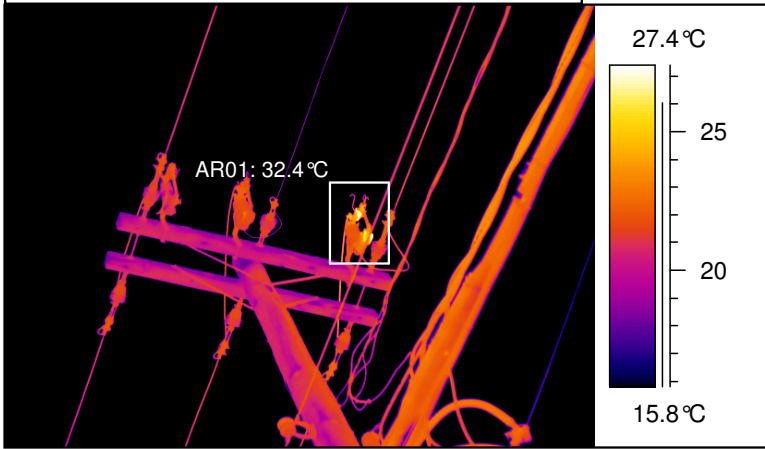
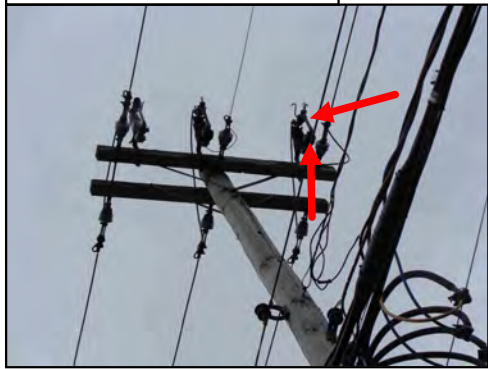
Temperature rise: 13.41 °C
(over ambient)

Infrared image of the cut-out switches AY34 on pole # ET0884.
 Located behind Optimist Club in Aylmer.
 Heating noted at the top and bottom of the south switch (at arrows in photo).
 See IR information chart above for maximum temperature inside area box (AR01).

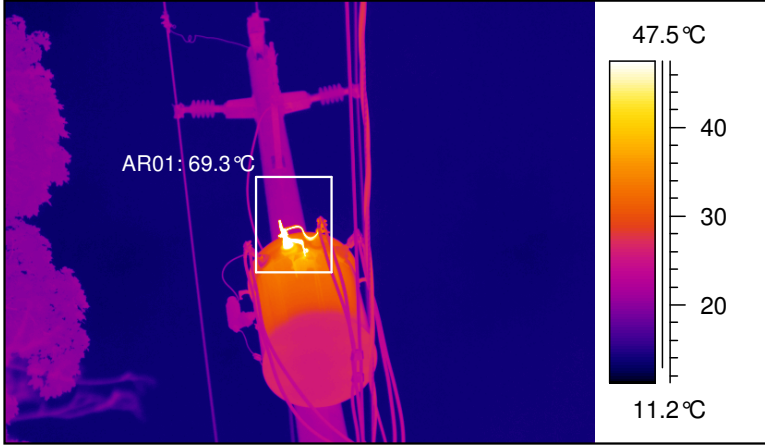
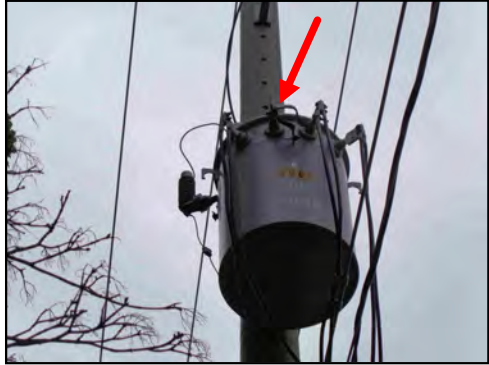
Temperature rise: 49.30 °C
(over ambient)

Infrared image of the transformer A0500 on pole # ET2708.
 Located at 103 Sydenham Street in Aylmer.
 Heating noted at the indicated ground connection (at arrow in photo).
 See IR information chart above for maximum temperature inside area box (AR01).

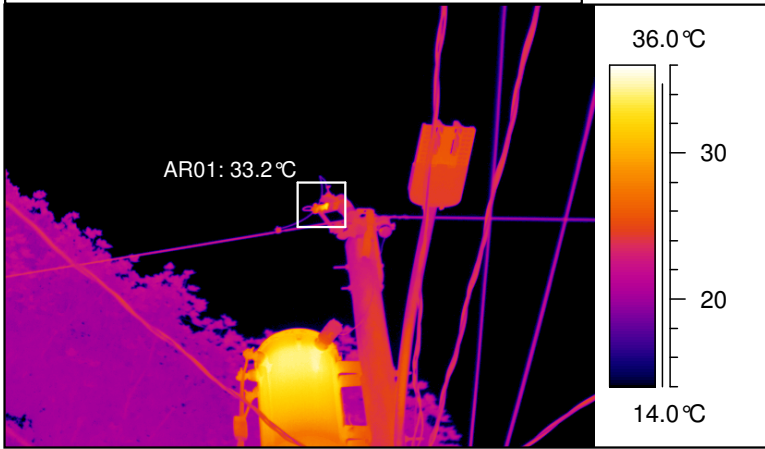
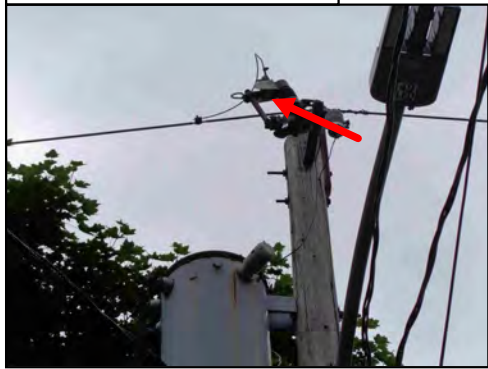
Temperature rise: 13.16 °C
(over ambient)

Infrared image of the cut-out switch A0112 on pole # ET0477.
 Located across 24 Street George Street in Aylmer.
 Heating noted at the switch contacts (at arrow in photo).
 See IR information chart above for maximum temperature inside area box (AR01).

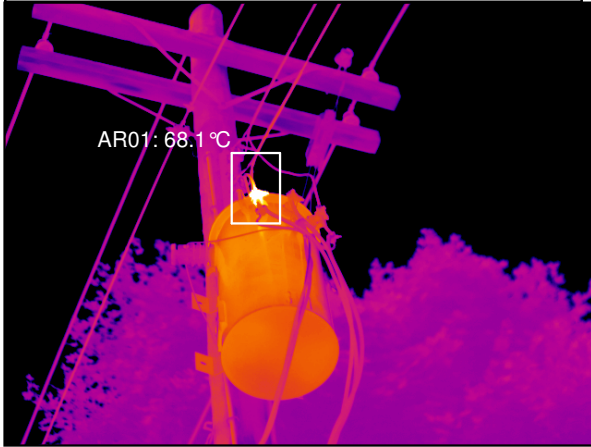
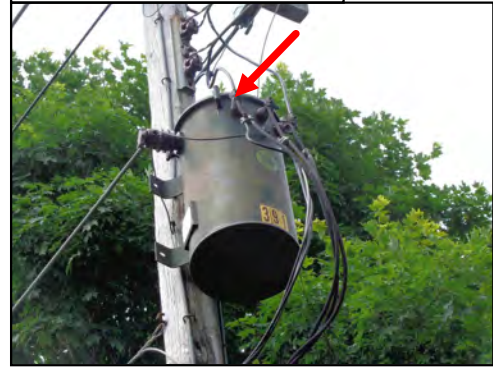
Temperature rise: 47.08 °C
(over ambient)

Infrared image of the transformer A0185 on pole # ET0737.
 Located at 120 Fourth Avenue in Aylmer.
 Heating noted at the indicated secondary connection (at arrow in photo).
 See IR information chart above for maximum temperature inside area box (AR01).

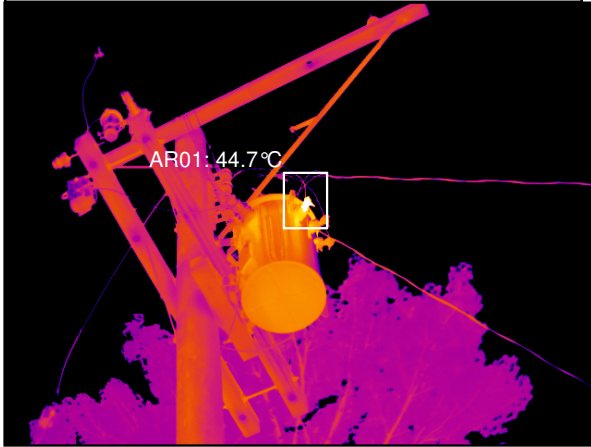
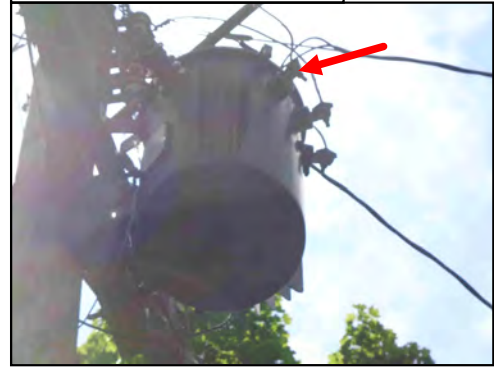
Temperature rise: 21.73 °C
(over ambient)

Infrared image of the transformer PS021.
 Located at 453 Front Street in Port Stanley.
 Heating noted at the indicated secondary connection (at arrow in photo).
 See IR information chart above for maximum temperature inside area box (AR01).

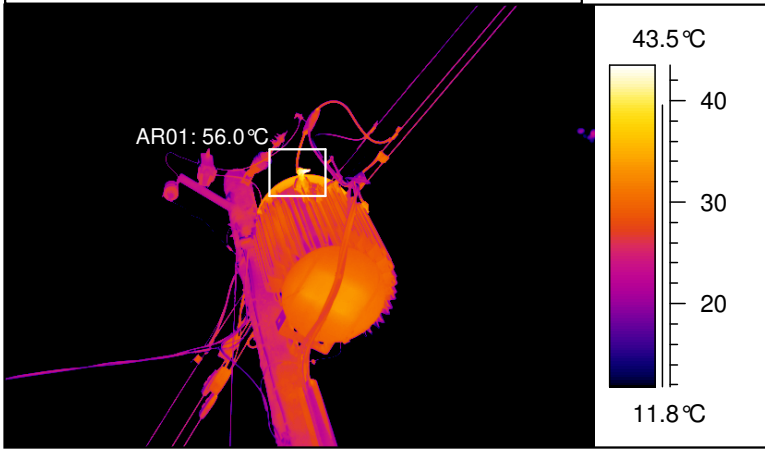
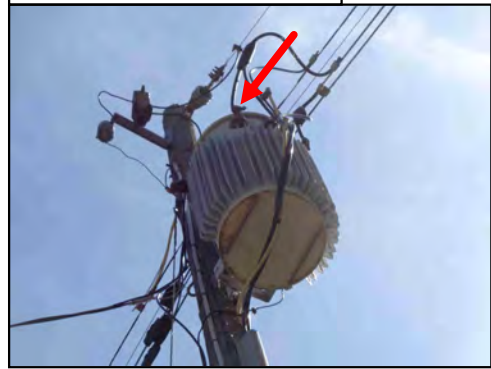
Temperature rise: 33.00 °C
(over ambient)

Infrared image of the transformer PS084, pole # ET8542.
 Located at 214 Cornell Drive in Port Stanley.
 Heating noted at the indicated secondary connection (at arrow in photo).
 See IR information chart above for maximum temperature inside area box (AR01).

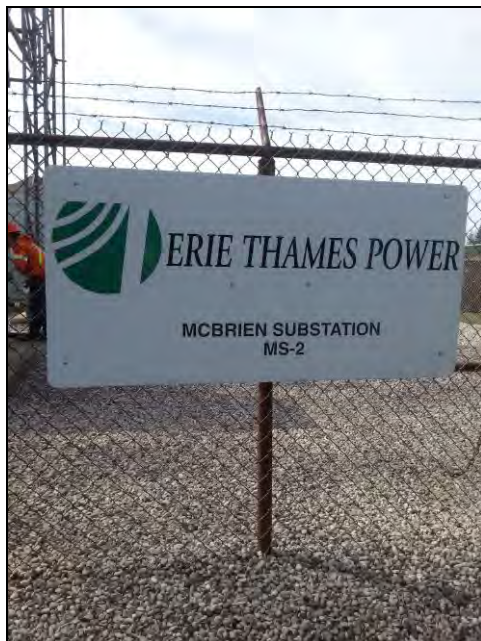
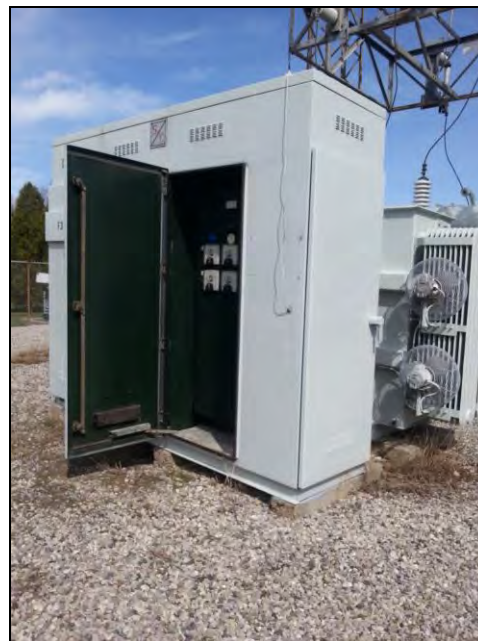
- Rodent droppings indicate a lot of mice in the switch
 - placed rodent poison inside switches for mice/rodents control

- HV Switch was found seized and difficult to open during maintenance
- Low insulation resistance results for 'A' phase lightning arrester on main tower
- Insulation resistance results were low for HV Switches F3 and F4
- Poor insulation resistance results for *Dielectric Absorption* on both transformers due to high humidity during testing
- All HV Switch Nameplates found very faded and difficult to read

- Cleanup and seal all switches particularly the bases, to keep moisture and mice out
- Replace lightning arrester exhibiting low insulation resistance

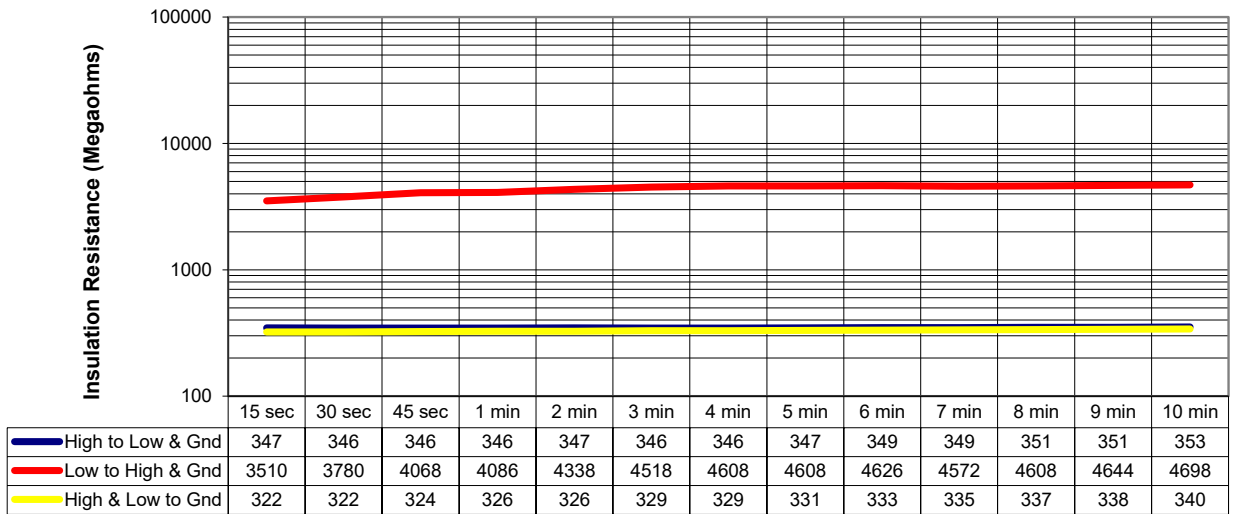
Comments: **VERY POOR (FLAT) RESULTS DUE TO HIGH HUMIDITY DURING TESTING**

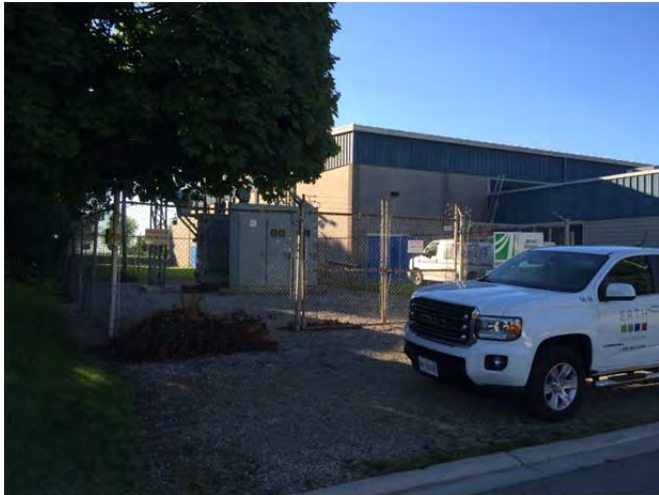
Mitchell MS2

-Tree growing over fence gives easy access and should be considered to be trimmed.

-Silica gel needs to be changed during the next inspection.

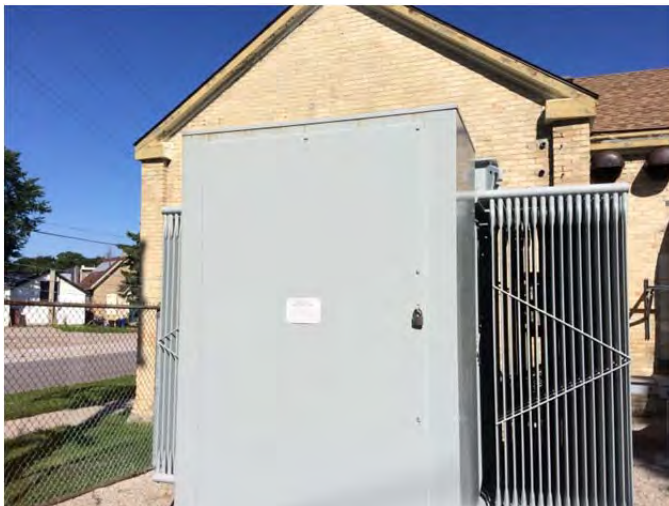
Clinton MS1

-Transformer fans running initially, resetting peak on temperature gage and fans shut off contacts in gage may be sticking, will need to monitor

-minor rusting around top of junction box, rest of new paint looks fine

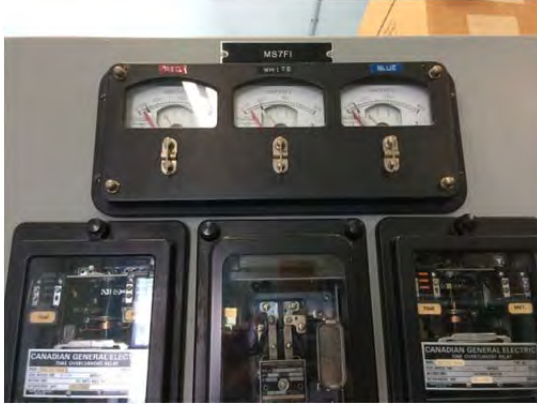
Clinton MS#1 – continue

-Note, if the peak demand meter indicators for each circuit are all measured at the same time of day then the transformer is operating near full load, combined with imbalanced load could be the reason for gas levels seen recently in transformer oil

-max demand on B phase on all 3 circuits is approx. 600 Amps

-Volt meter on gear has been disconnected

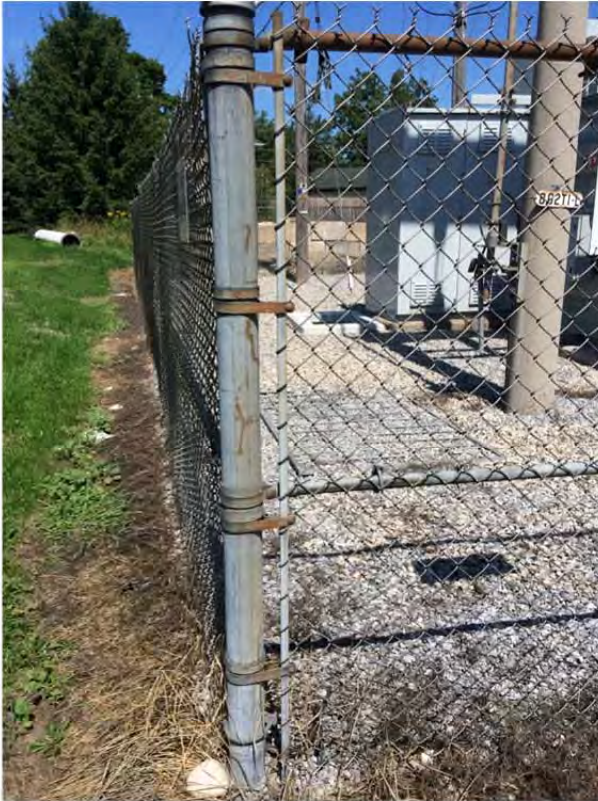
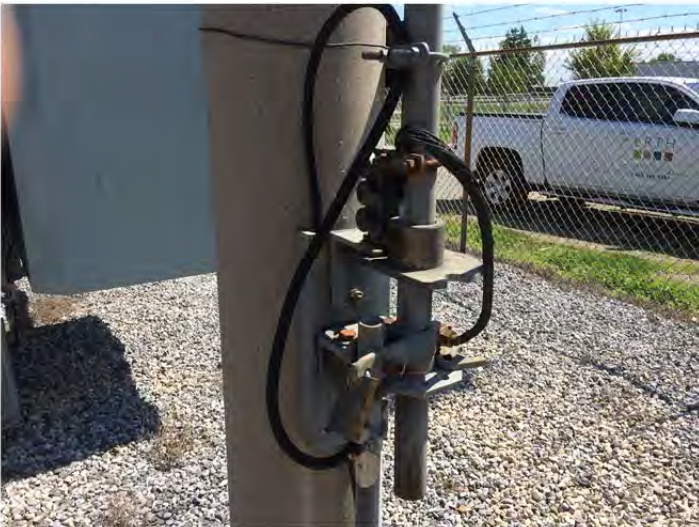
Tavistock

-Another ground wire found stolen from station fence, replacement to be scheduled, 3 spots on fabric are now missing

-fence company should be notified to repair fence fabric

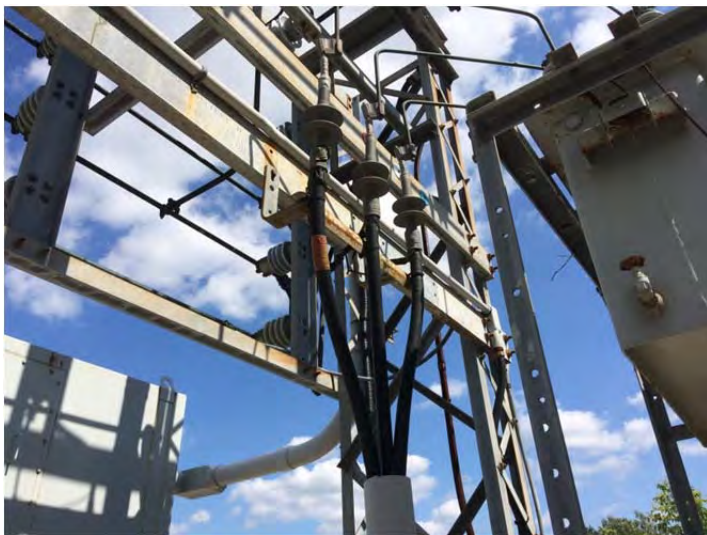
Beachville MS1

-Termination that has been split for some time does not appear to have deteriorated from previous inspection

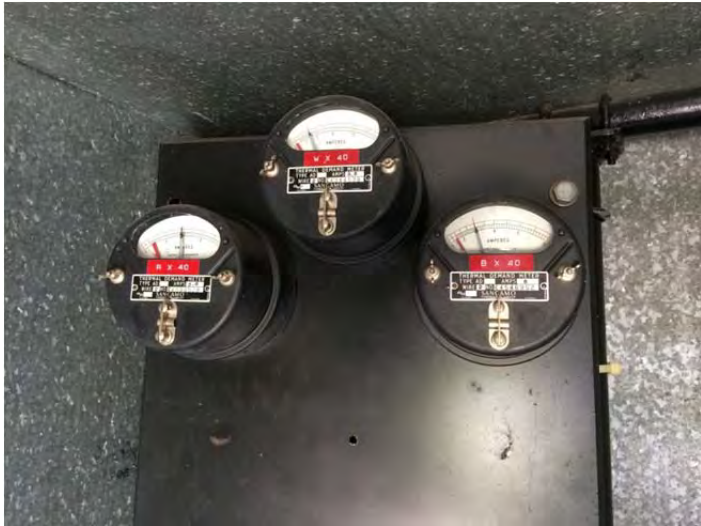
Beachville MS1 - continue

-Max load points not indicating a balanced loading, may contribute to transformer oil gasing situation

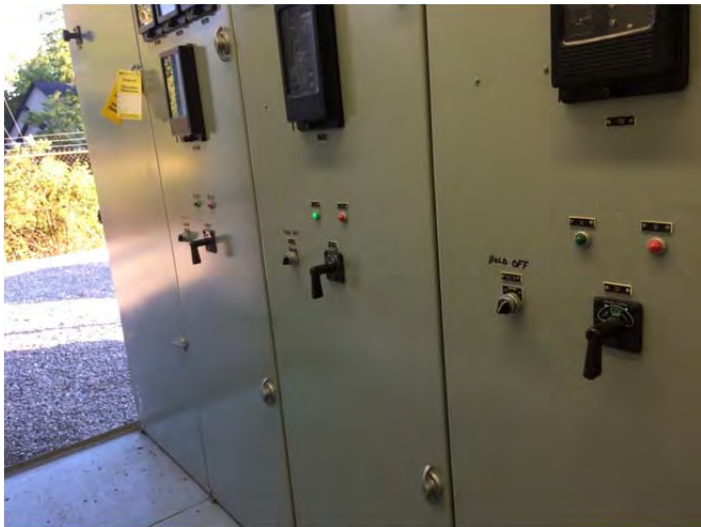
Port Stanley MS1

-open/closed indicator lights changed on feeders 2 & 3

-evidence of rodent and bug infestation in building, screen should be added to intake vent.

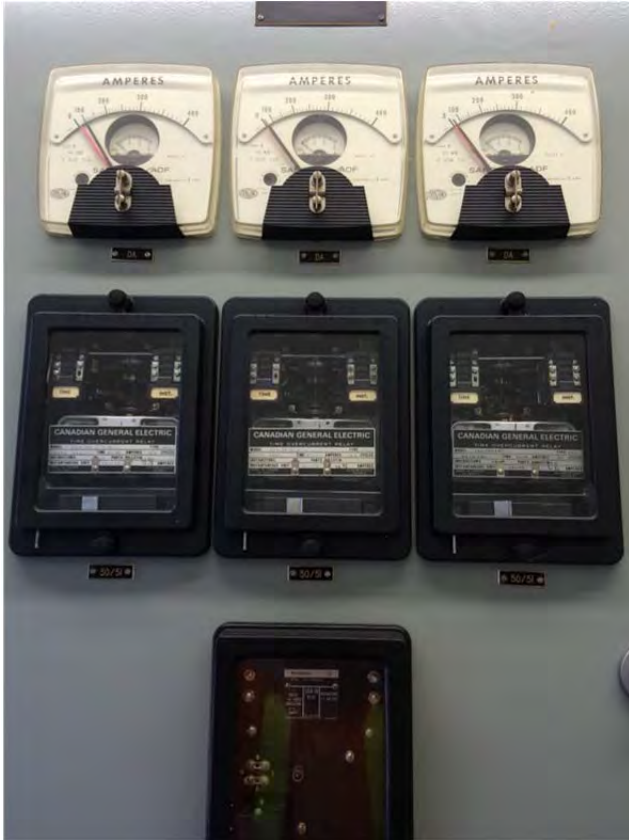
Port Stanley MS1 – continued

- Peak load demand 325 amps
- Very imbalanced loading
- Reset peak load demand settings

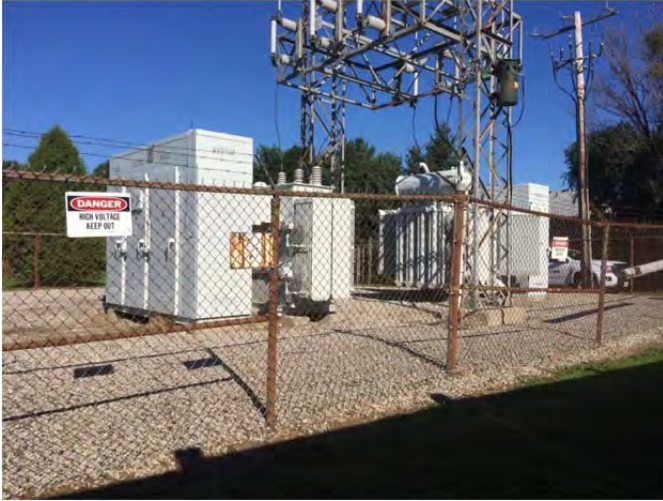
Aylmer McBrien MS2

-Fans on south (T2) transformer turned on automatically at 50 C while performing inspections

-Wasp nests forming in south transformer meter cabinet on end, spray needed

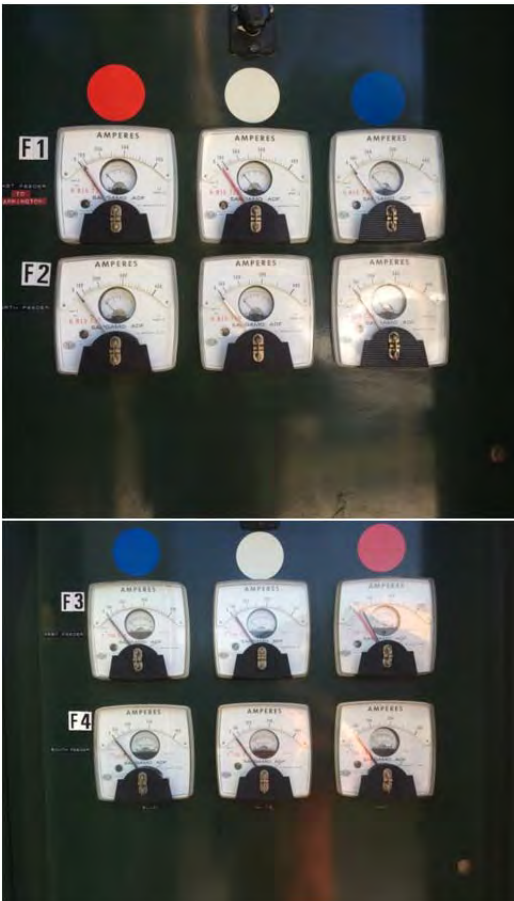
-F1 and F2 on North (T1) and F3 and F4 on the South (T2)

-Both lightly loaded

-Reset peak load demand settings

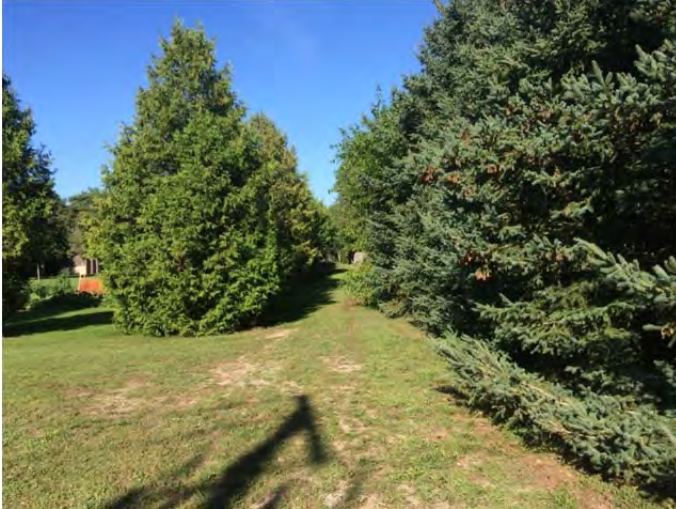
Aylmer McBrien MS2 - continued

-drive way to station becoming overgrown with trees, tree trimming needed

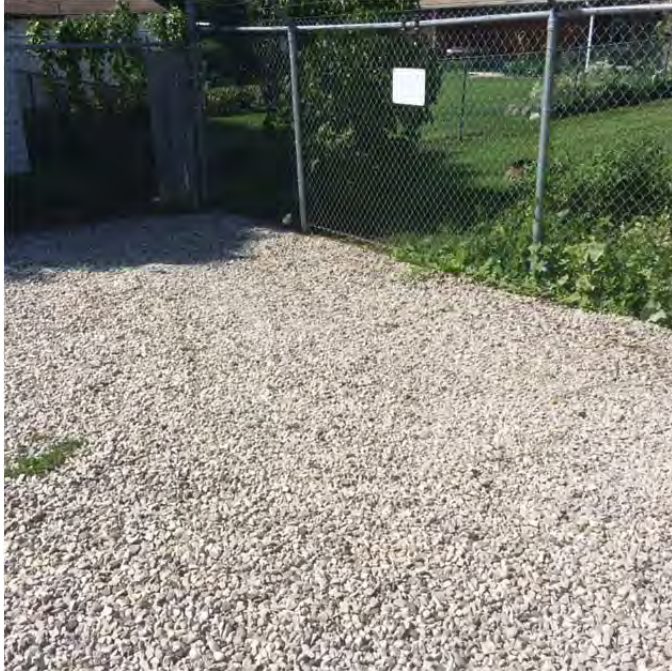
-Gap below fabric greater than 50 mm in many spots

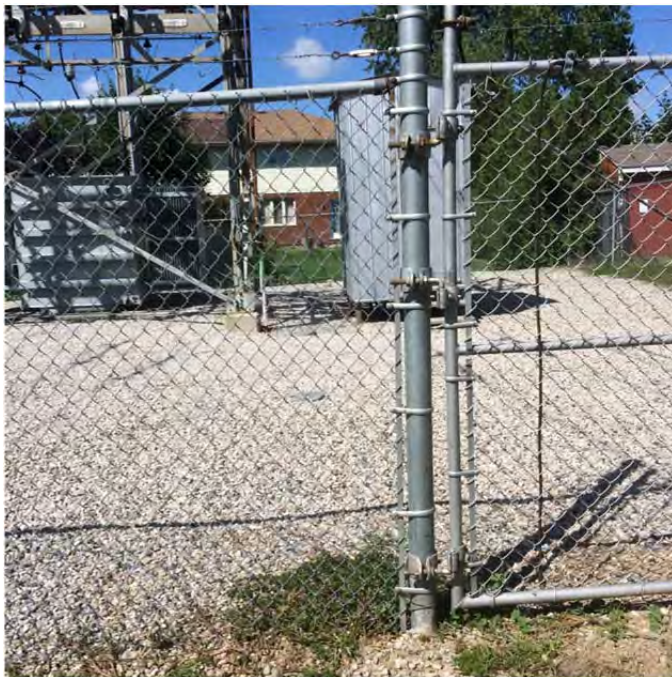
-gap below fence fabric

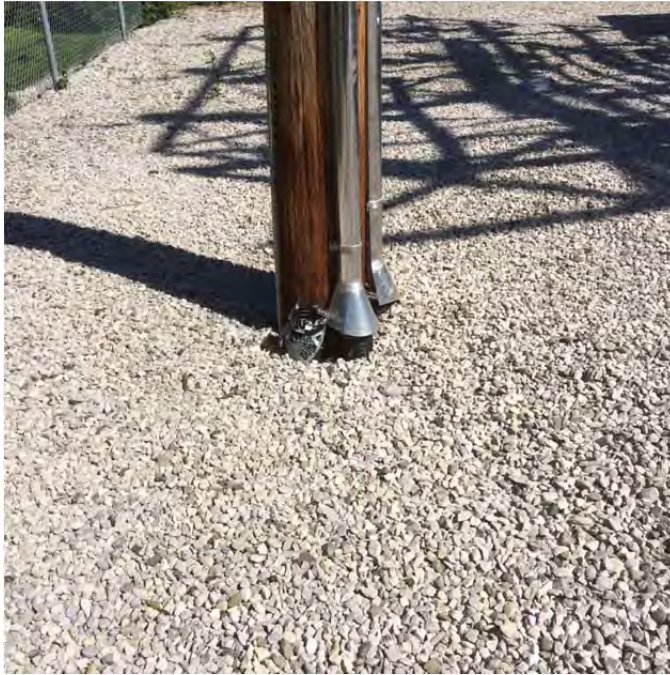
Aylmer Forest MS1 continue

-Spare duct should be better sealed

-Additional stone needed around big O or cable guards should be lower to provide better protection of duct, Thin wall DB II not permitted above grade either should big O

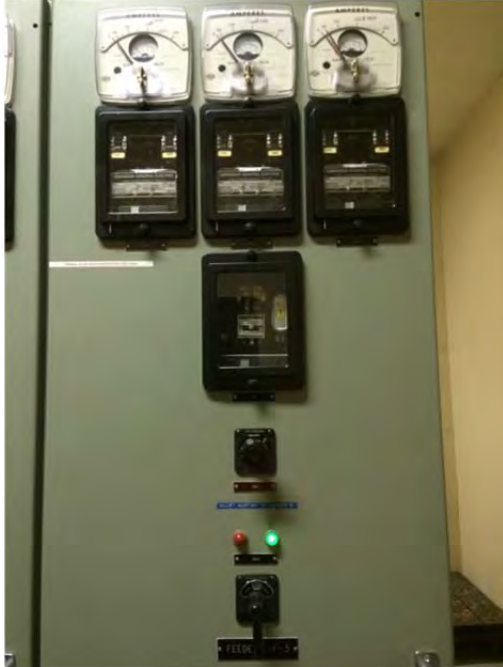
Ingersoll MS1 - continued

- Battery bank liquid levels okay
- Batteries should be serviced, tested and corrosion removed
- Feeders lightly loaded
- Reset peak load demand settings

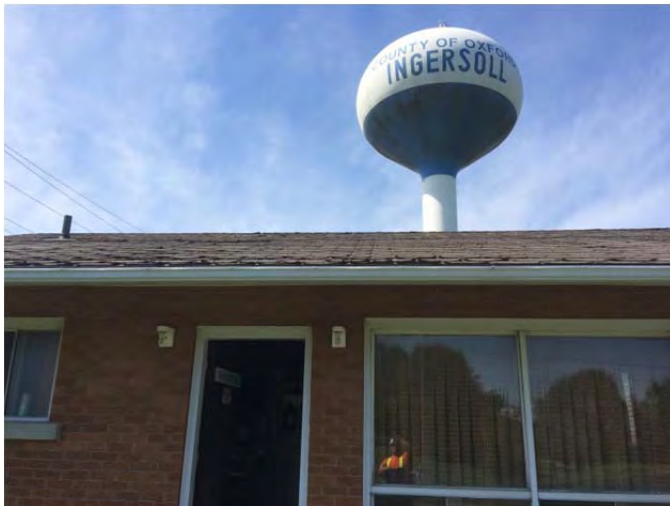
Ingersoll MS3

- Building maintenance needed, roof, front door and garage door need painting

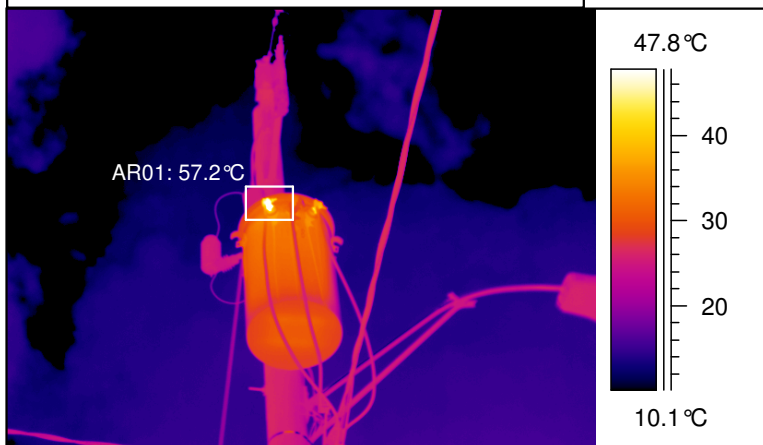
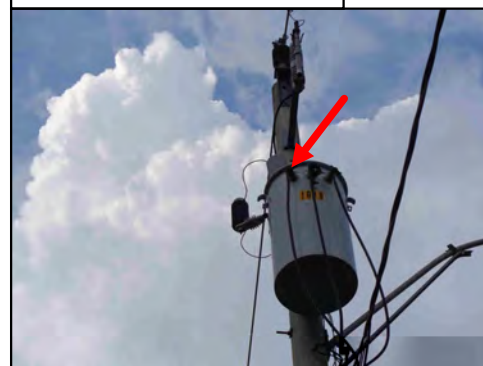
Description: Transformer

Temperature rise: 32.23 °C
(over ambient)

IR information	Value
Date of creation	2014-06-17
Object parameter	Value
Ambient temperature	25.0°C
Label	Value
AR01 : max	57.2°C

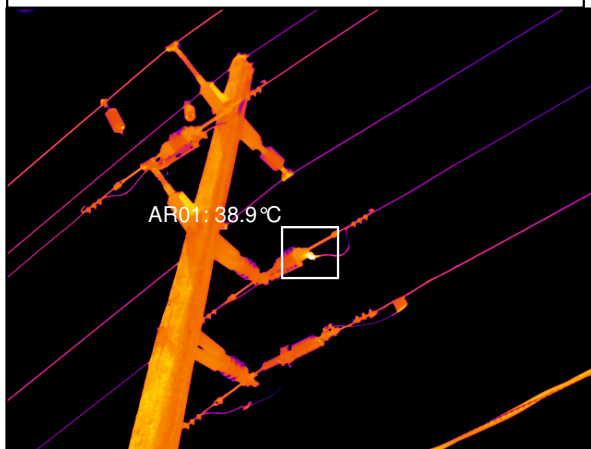
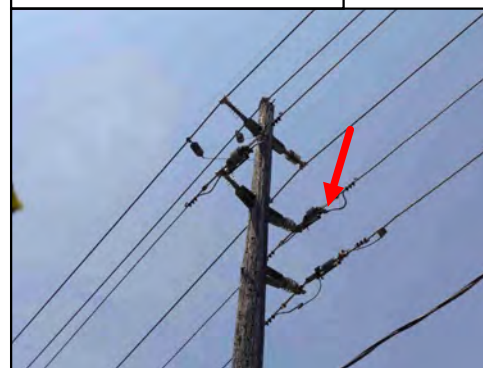
Description: In-line switches

Temperature rise: 10.93 °C
(over ambient)

IR information	Value
Date of creation	2014-06-17
Object parameter	Value
Ambient temperature	28.0°C
Label	Value
AR01 : max	38.9°C

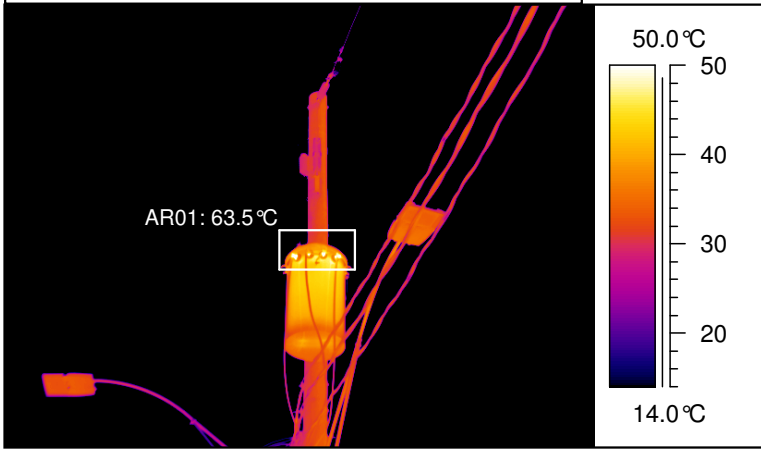
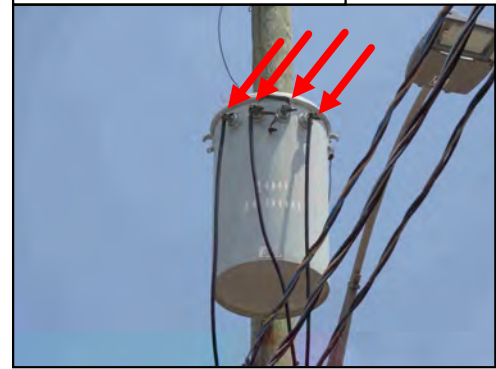
Description: Transformer

Temperature rise: 35.47 °C
(over ambient)

IR information	Value
Date of creation	2014-06-17
Object parameter	Value
Ambient temperature	28.0°C
Label	Value
AR01 : max	63.5°C

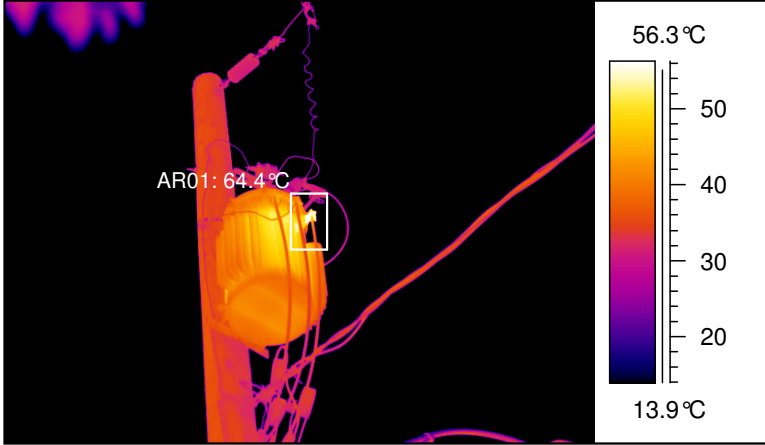
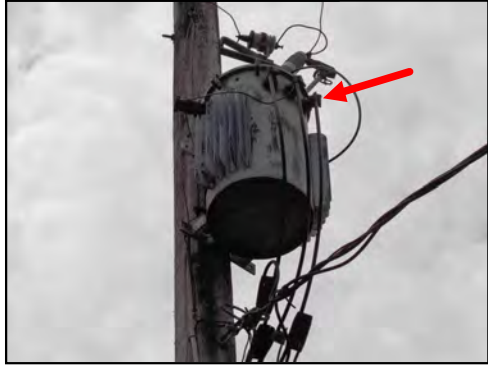
Description: Transformer

Temperature rise: 36.43 °C
(over ambient)

IR information	Value
Date of creation	2014-06-17
Object parameter	Value
Ambient temperature	28.0°C
Label	Value
AR01 : max	64.4°C

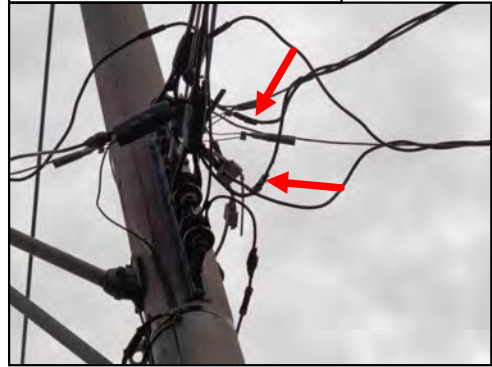
Temperature rise: 44.78 °C
(over ambient)

IR information	Value
Date of creation	2014-06-17
Object parameter	Value
Ambient temperature	28.0°C
Label	Value
AR01 : max	72.8°C

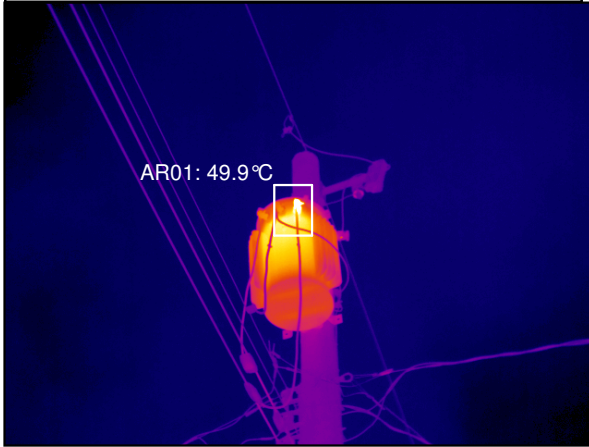
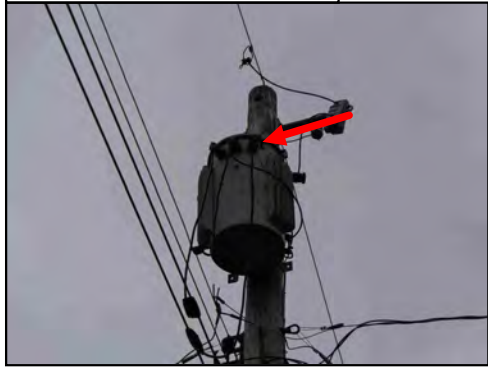
Description: Transformer

Temperature rise: 31.87 °C
(over ambient)

IR information	Value
Date of creation	2014-06-18
Object parameter	Value
Ambient temperature	18.0°C
Label	Value
AR01 : max	49.9°C

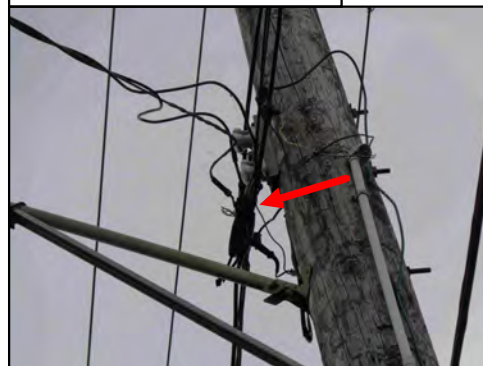
Temperature rise: 18.42 °C
(over ambient)

IR information	Value
Date of creation	2014-06-18
Object parameter	Value
Ambient temperature	18.0°C
Label	Value
AR01 : max	36.4°C

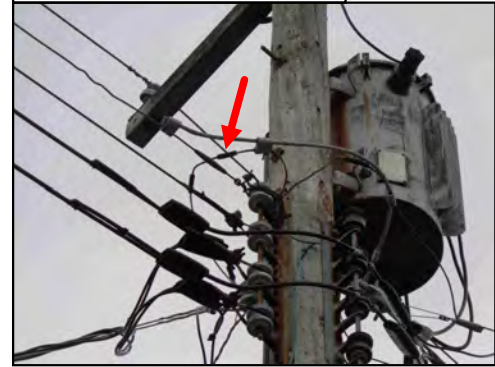
Temperature rise: 14.39 °C
(over ambient)

IR information	Value
Date of creation	2014-06-18
Object parameter	Value
Ambient temperature	18.0°C
Label	Value
AR01 : max	32.4°C

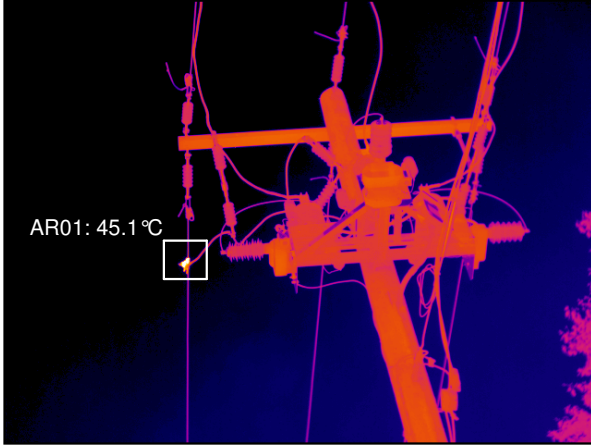
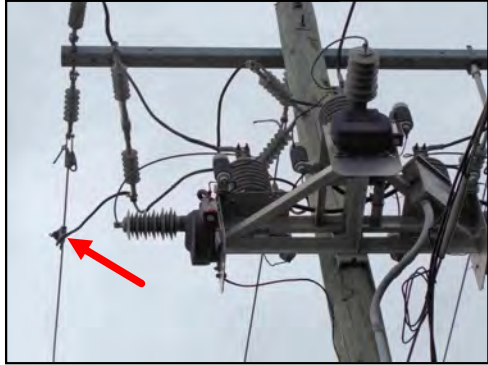
Description: In-line switches

Temperature rise: 26.06 °C
(over ambient)

IR information	Value
Date of creation	2014-06-18
Object parameter	Value
Ambient temperature	19.0°C
Label	Value
AR01 : max	45.1°C

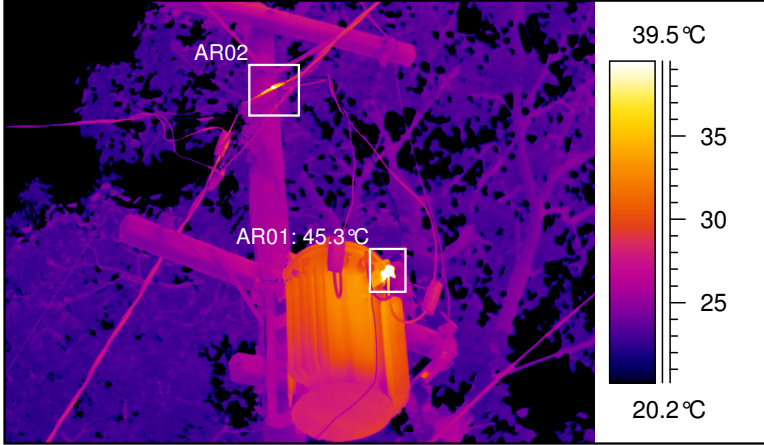
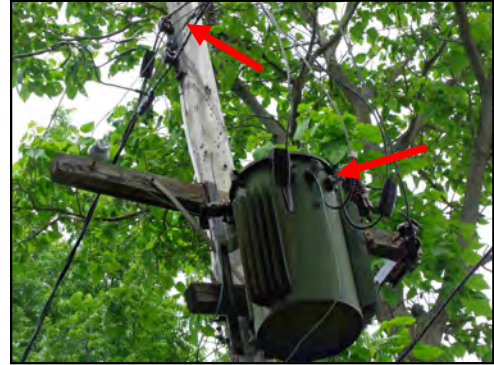
Description: Transformer

Temperature rise: 26.31 °C
(over ambient)

IR information	Value
Date of creation	2014-06-18
Object parameter	Value
Ambient temperature	19.0°C
Label	Value
AR01 : max	45.3°C
AR02 : max	42.6°C

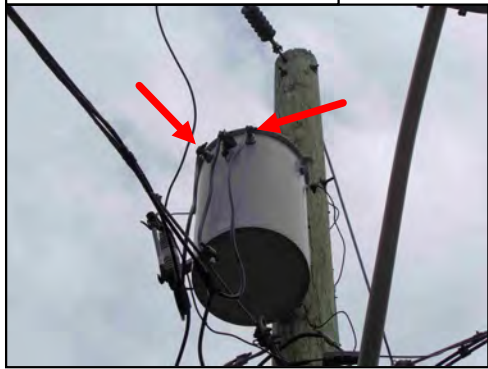
Temperature rise: 24.75 °C
(over ambient)

IR information	Value
Date of creation	2014-06-18
Object parameter	Value
Ambient temperature	23.0°C
Label	Value
AR01 : max	47.7°C

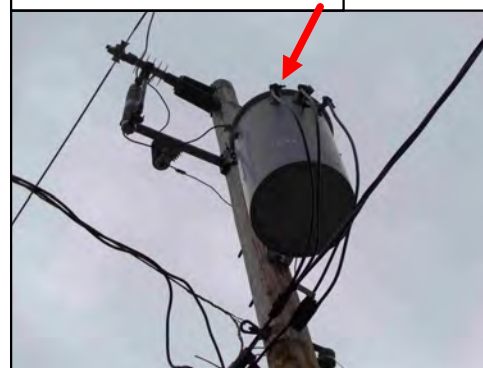
Temperature rise: 16.96 °C
(over ambient)

IR information	Value
Date of creation	2014-06-18
Object parameter	Value
Ambient temperature	23.0°C
Label	Value
AR01 : max	40.0°C

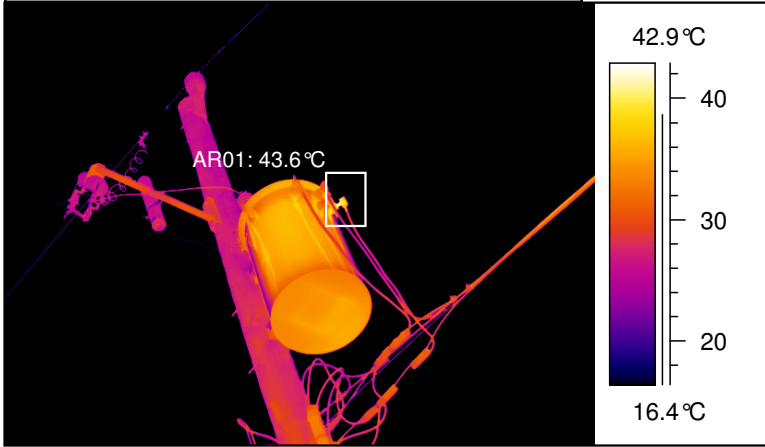
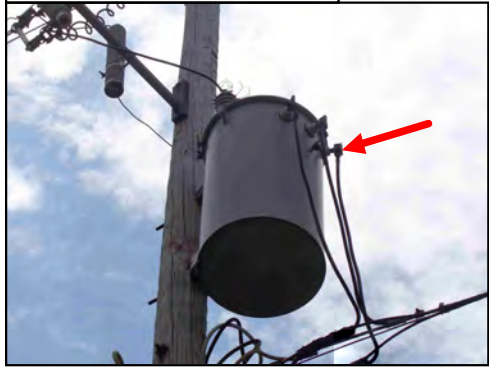
Description: Transformer

Temperature rise: 20.57 °C
(over ambient)

IR information	Value
Date of creation	2014-06-18
Object parameter	Value
Ambient temperature	23.0°C
Label	Value
AR01 : max	43.6°C

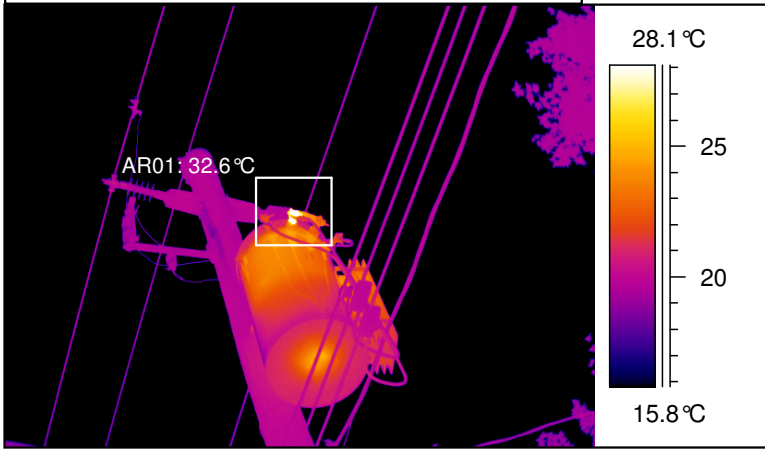
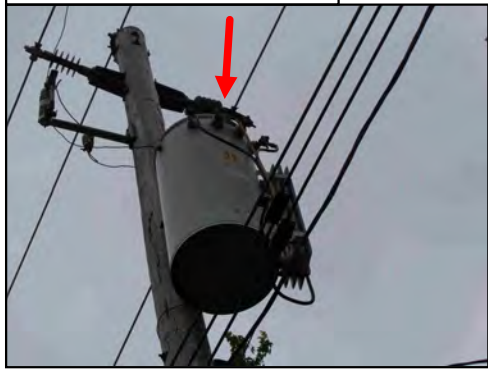
Description: Transformer

Temperature rise: 14.61 °C
(over ambient)

IR information	Value
Date of creation	2014-06-19
Object parameter	Value
Ambient temperature	18.0°C
Label	Value
AR01 : max	32.6°C

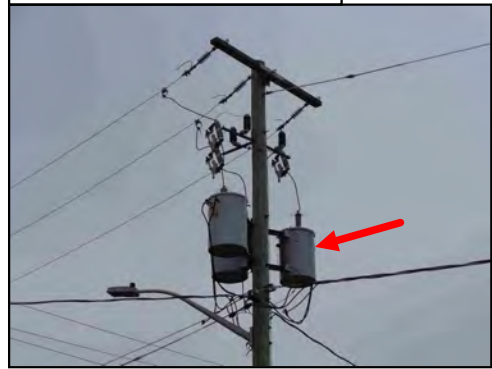
PHOTO

Temperature rise: 15.07 °C
(over ambient)

Infrared image of the transformer A0188 on pole # ET0103.
 Located on Spruce Street in Aylmer.
 Uneven transformer heating was noted.
 See IR information chart above for maximum temperature inside area box (AR01).
